SUMMARY

1234 Main Street Rockford IL 61101

Dan Aranki
IL License No. 450.013334, interNACHI
Certified Professional Inspector®
D.A. Inspections
(815) 765-4324
info@da-inspections.com

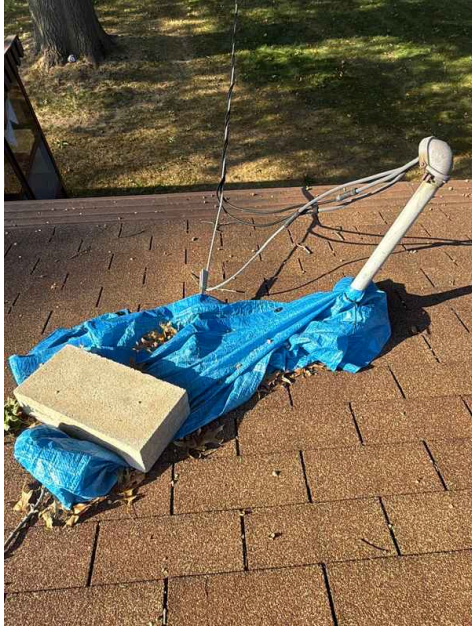
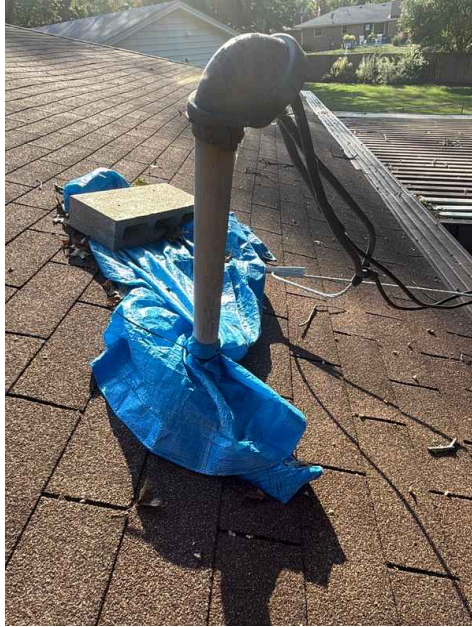
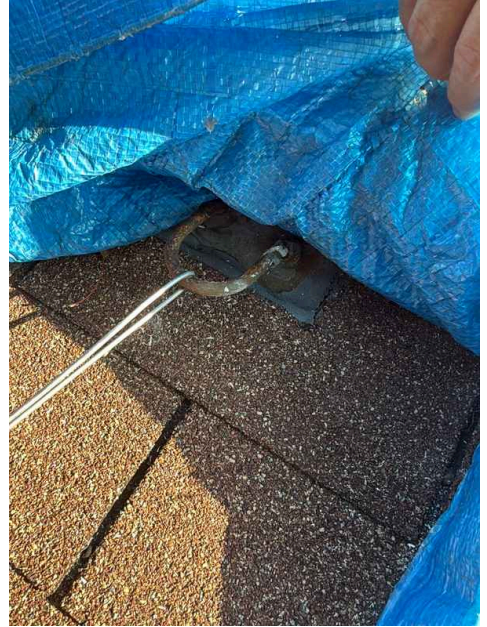
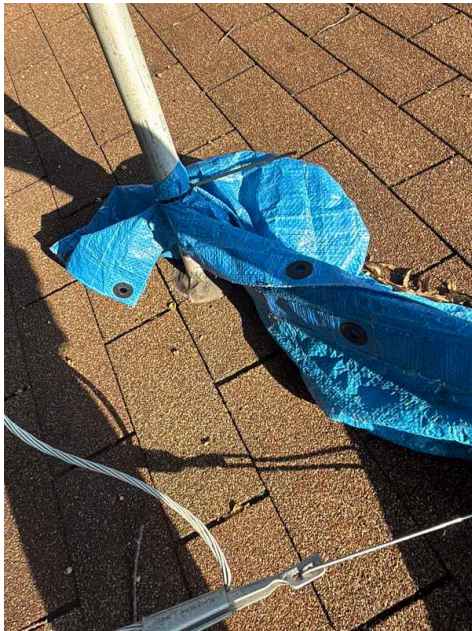
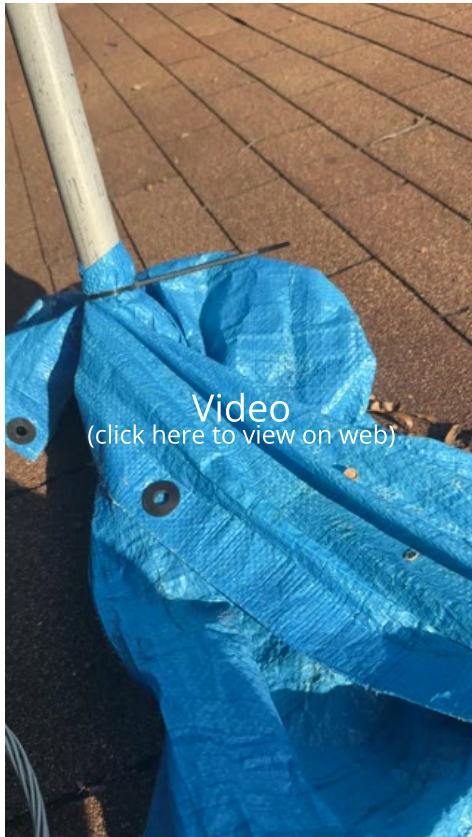
2.3.1 Exterior Systems

DAMAGE AT MAST

Damage was observed at the electrical service mast. A damaged mast can compromise the safe support and protection of service conductors, creating fire and shock hazards. **Immediate evaluation and repair by the electrical utility provider or a licensed electrician are recommended.**

Contact a qualified electrical contractor.

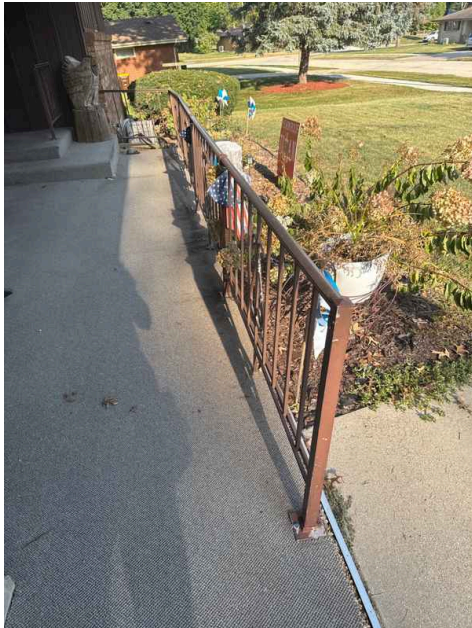
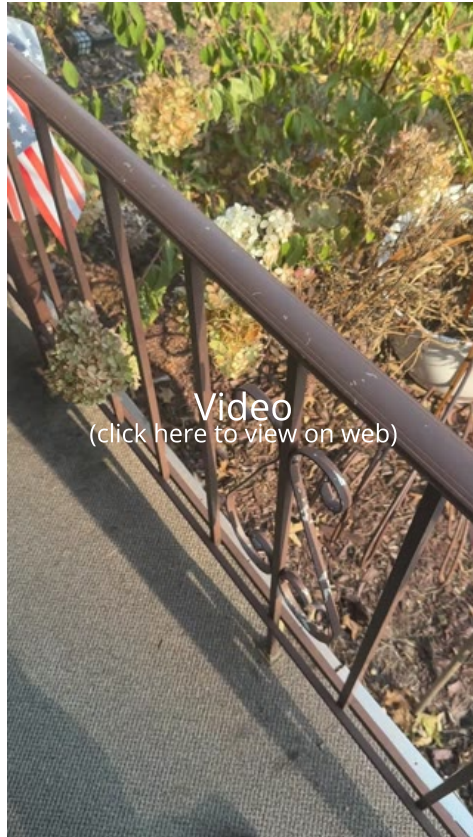
2.6.1 Decks / Porches / Railings

LOOSE RAILING COMPONENT

A loose railing component was observed. This condition presents a safety hazard, as it may not provide adequate support. Correction and further evaluation by a qualified contractor is recommended.

Recommendation
Contact a qualified handyman.

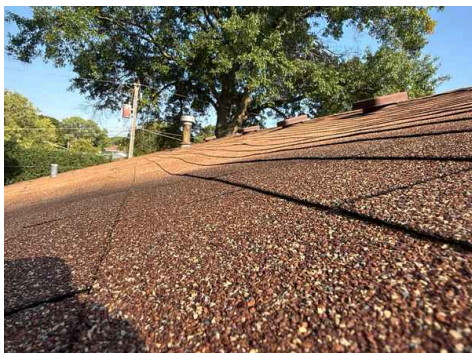
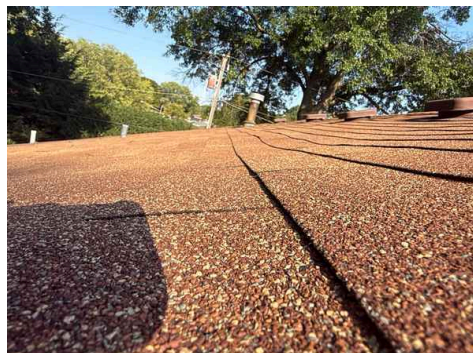
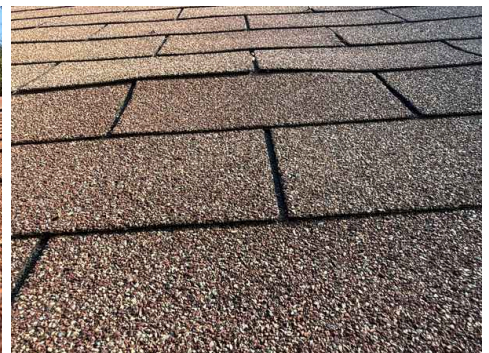
3.1.1 Roof Covering Materials

ROOF SAG OR DEFLECTION

Areas of sag or deflection were observed in the roof structure. This condition may be due to undersized framing members, long-term moisture exposure, prior modifications, or natural aging of materials. While sagging is not uncommon in older homes, it may indicate weakening or stress in the structural components.

Further evaluation by a qualified roofing contractor or structural engineer is recommended to determine the cause and any necessary corrective action.

Recommendation
Contact a qualified roofing professional.

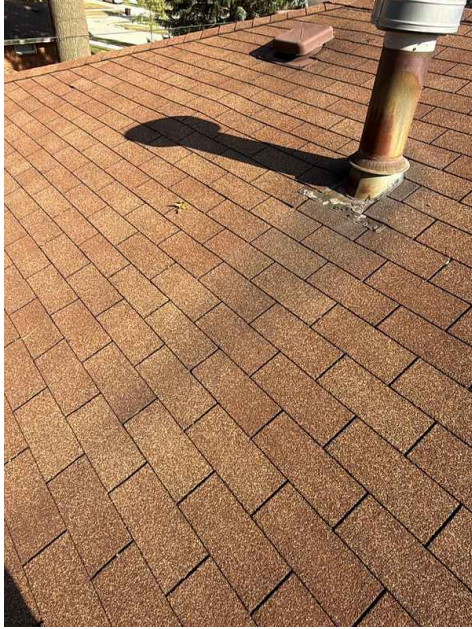
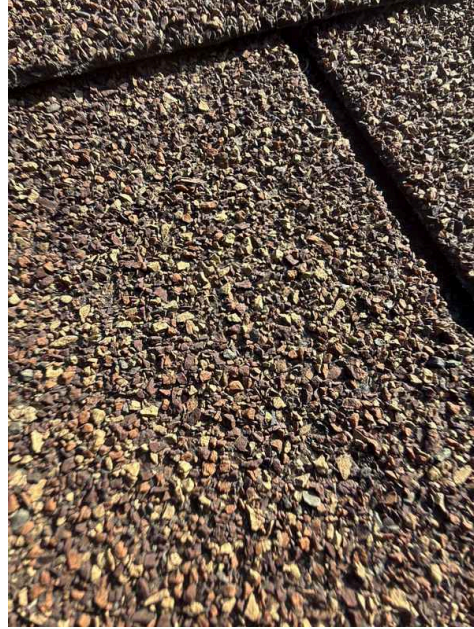
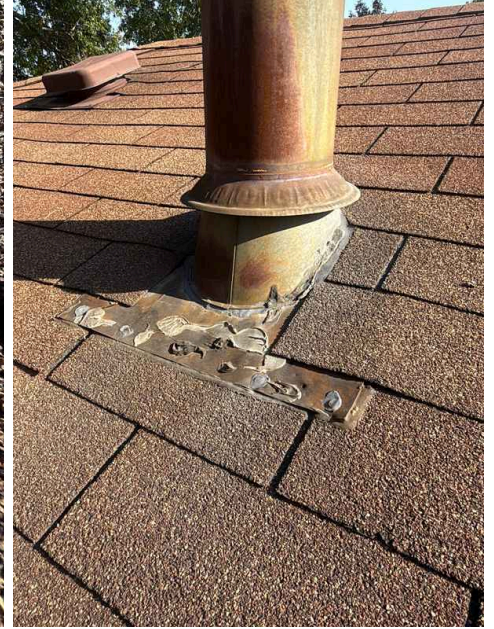
3.1.3 Roof Covering Materials

ROOF SYSTEM APPEARS AGED AND NEAR END OF EXPECTED SERVICE LIFE

The roof system appears to be aged and may be near or beyond its expected service life, based on visual observations and typical lifespan data from [InterNACHI's Standard Estimate Life Expectancy Chart for Homes](#). While no active leaks were confirmed, older roofing materials are more vulnerable to water intrusion, especially during severe weather. Ask the seller about recent roof performance and any prior repairs. Further evaluation and budgeting for repair or replacement by a qualified roofing contractor are recommended.

Recommend monitoring.

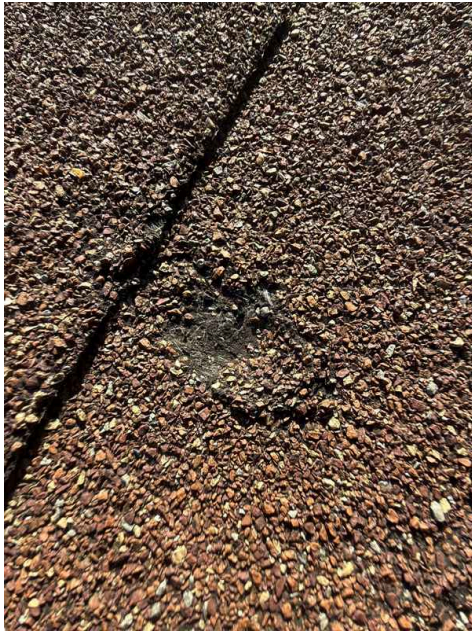
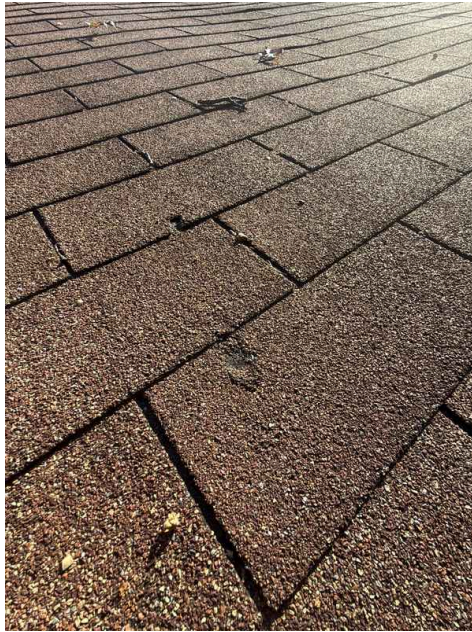
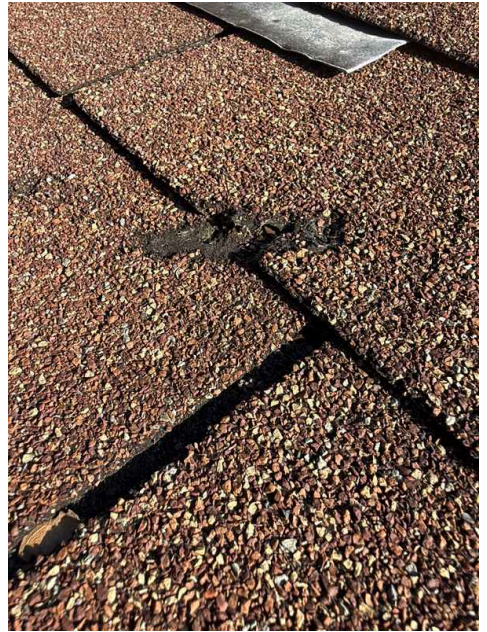
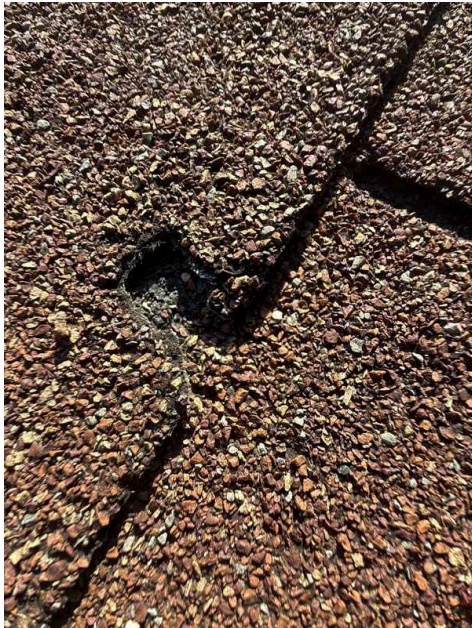
3.1.4 Roof Covering Materials

SUSPECTED HAIL DAMAGE TO ROOF COVERING

Areas of the roof covering exhibited marks consistent with possible hail damage. This condition may affect the service life of the roofing materials. Evaluation by a qualified roofing contractor is recommended.

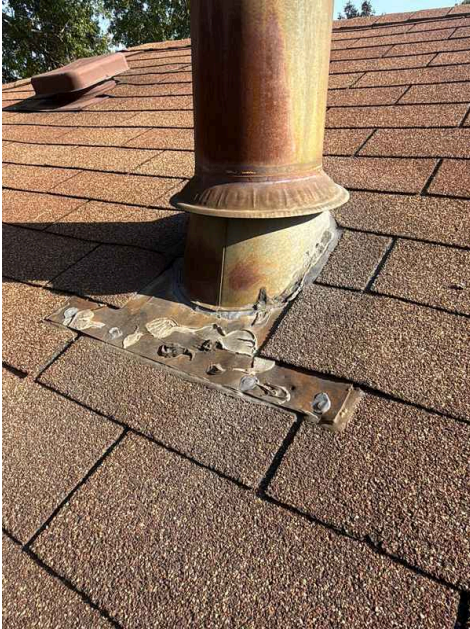
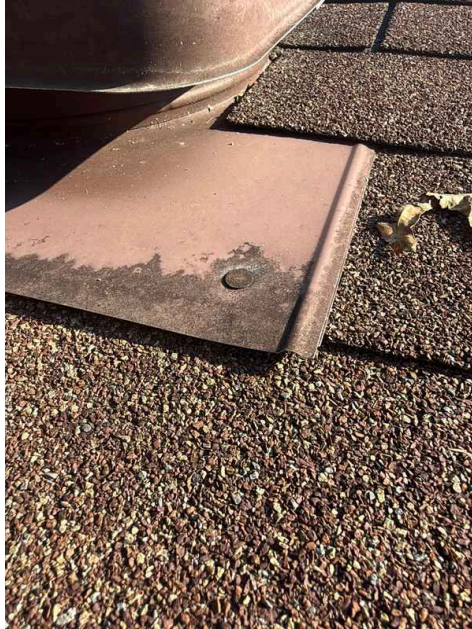
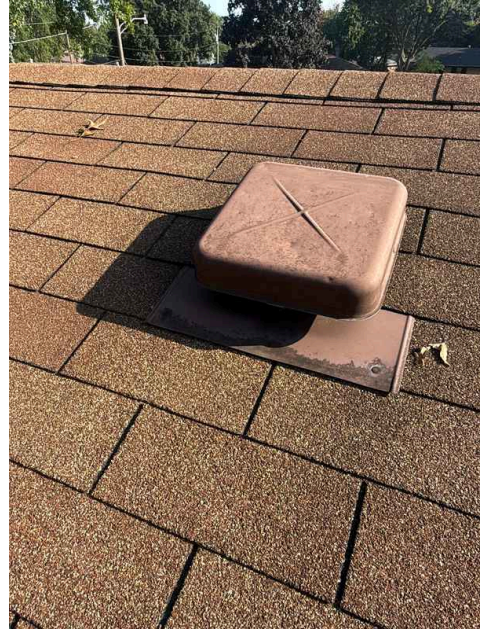
3.2.1 Flashing

VENT PIPE FLASHING DEFECT

Defects were observed at the vent pipe flashing. Flashing in these areas is intended to seal roof penetrations and prevent water intrusion. Damaged, improperly installed, or deteriorated vent pipe flashing increases the potential for roof leaks in affected areas. Correction and evaluation by a qualified roofing contractor is recommended.

Contact a qualified roofing professional.

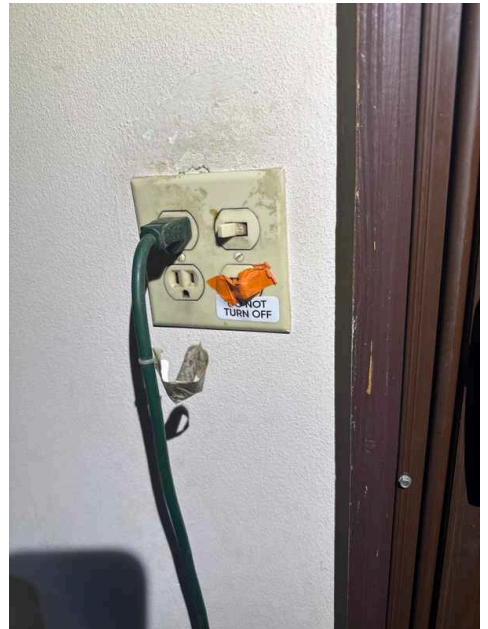
4.3.1 Garage Electrical

MISSING GFCI PROTECTION IN GARAGE

A receptacle in the attached garage was observed without ground-fault circuit interrupter (GFCI) protection. Current safety standards require GFCI protection for all 15- and 20-amp receptacles in garages, including outlets serving refrigerators, garage door openers, and washing machines. The absence of GFCI protection increases the risk of electrical shock. Installation of proper GFCI protection by a licensed electrician is recommended.

Contact a qualified electrical contractor.

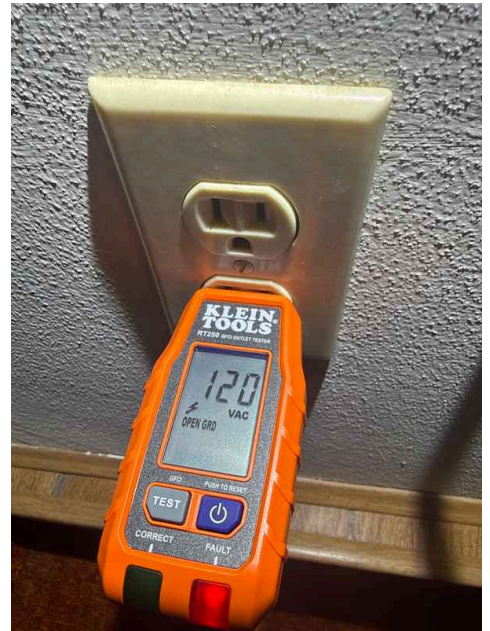
9.4.1 Switches, Fixtures, and Receptacles

MISSING GROUND AT RECEPTACLE

A receptacle was observed with a missing, open, or disconnected ground. A receptacle without proper grounding presents an electrical shock hazard and does not meet modern safety standards. Evaluation and repair by a licensed electrician is recommended.

Contact a qualified electrical contractor.

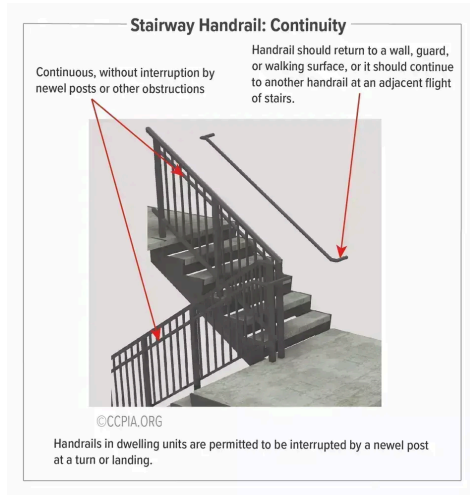
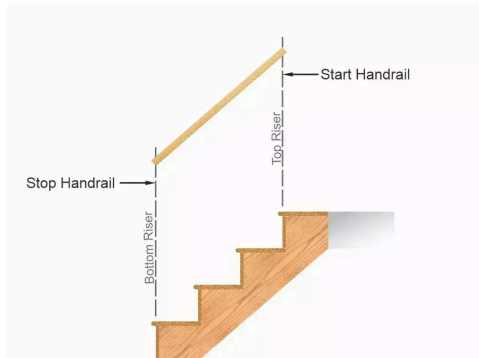
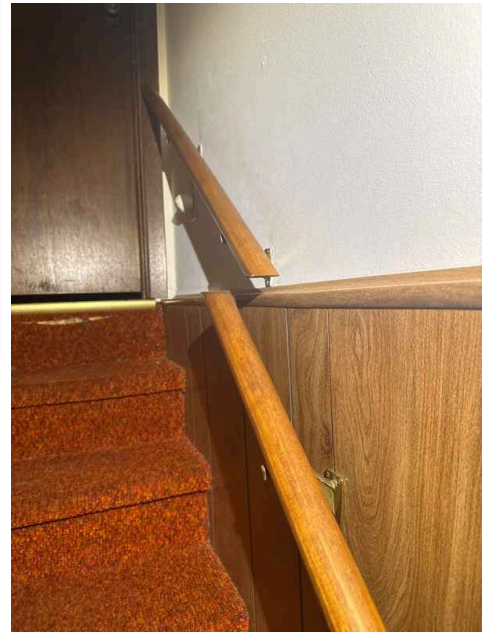
9.5.1 Interior Stairs, Steps, and Ramps

HANDRAIL IS NOT CONTINUOUS

A handrail that is not continuous was observed. Handrails for stairs should be continuous for the full length of the stairway. This condition may present a safety hazard. Correction and further evaluation by a qualified contractor is recommended.

Contact a qualified professional.

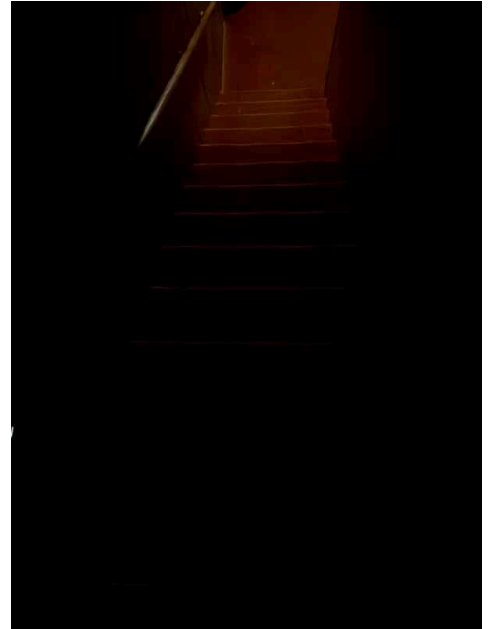
9.5.2 Interior Stairs, Steps, and Ramps

STAIRWAY ILLUMINATION

Inadequate illumination was observed at the stairway. Proper lighting should be provided for stairways, treads, risers, and landings to reduce the risk of trips or falls. For exterior stairs, a light fixture should be present at the top landing. Correction and further evaluation is recommended.

Contact a qualified professional.

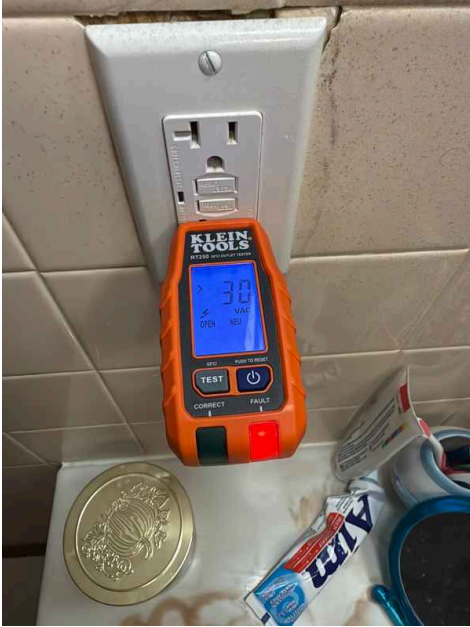
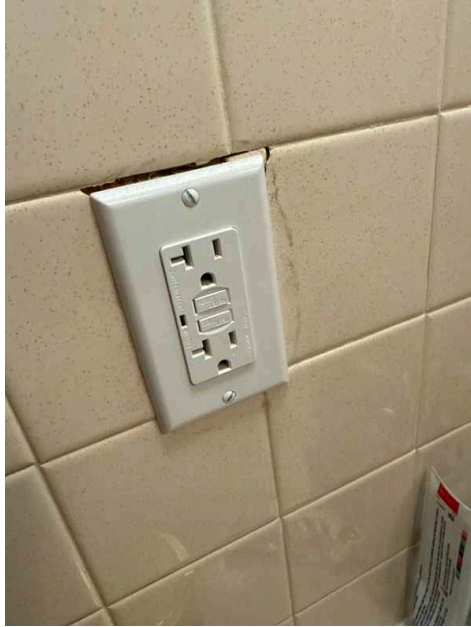
13.4.1 Switches, Fixtures, Receptacles, and GFCI Protection

BATHROOM RECEPTACLE NOT GFCI PROTECTED

A receptacle in the bathroom was observed to lack ground-fault circuit interrupter (GFCI) protection. The absence of GFCI protection in wet locations increases the risk of electrical shock. Installation of a properly functioning GFCI device by a licensed electrician is recommended.

Contact a qualified electrical contractor.

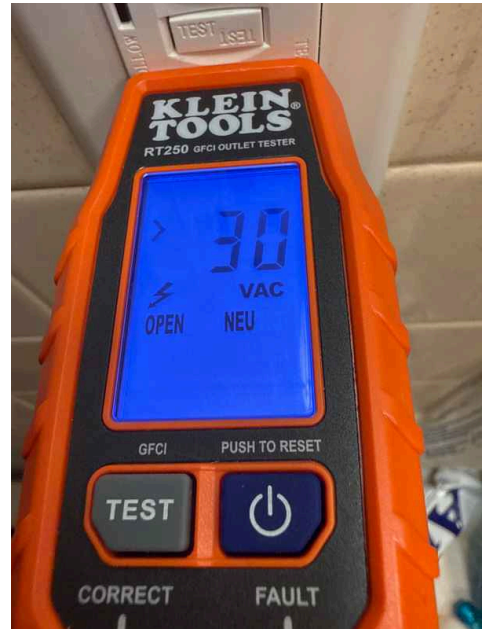
13.4.2 Switches, Fixtures, Receptacles, and GFCI Protection

GFCI IMPROPERLY WIRED

A ground-fault circuit interrupter (GFCI) receptacle in the bathroom was observed to be improperly wired. An improperly wired GFCI may not provide the intended protection against electrical shock. Evaluation and repair by a licensed electrician is recommended.

Contact a qualified electrical contractor.

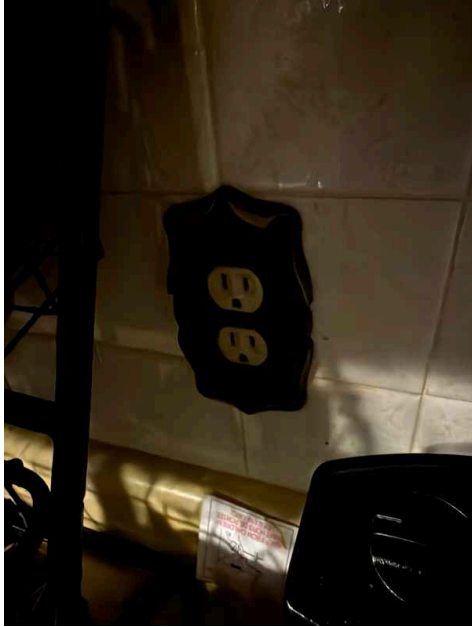
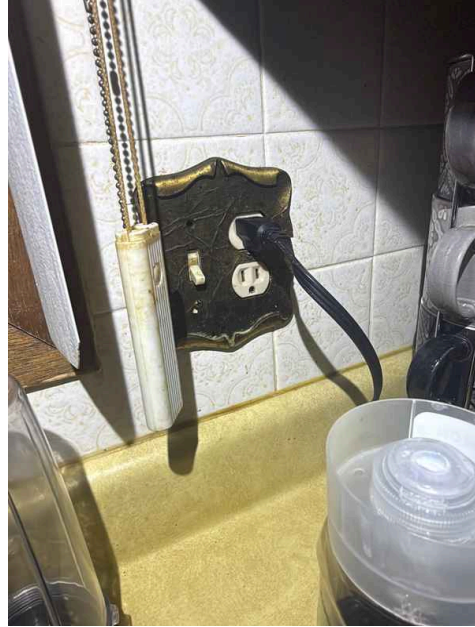
15.4.1 Switches, Fixtures, Receptacles, and GFCI Protection

MISSING GFCI PROTECTION - KITCHEN

GFCI protection was not present at one or more kitchen countertop receptacles. All kitchen countertop receptacles are required to be GFCI protected to reduce the risk of electrical shock in wet areas. Installation of GFCI protection by a qualified electrical contractor is recommended.

Contact a qualified electrical contractor.

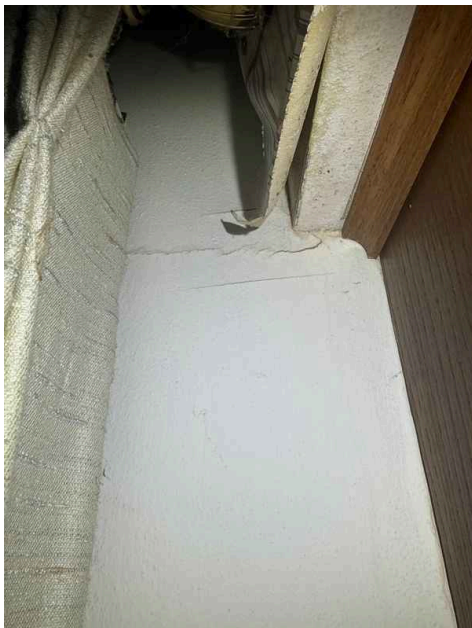
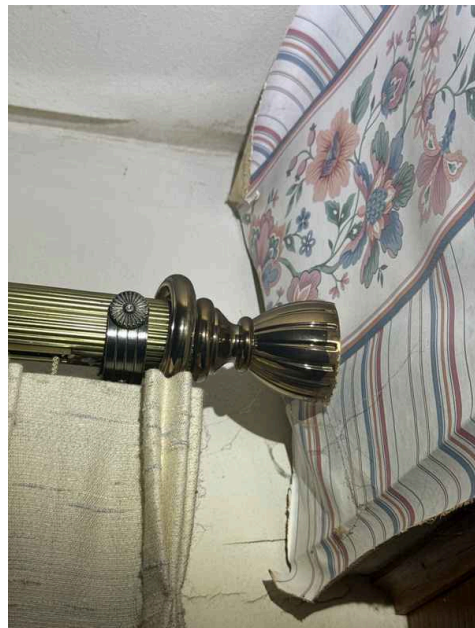
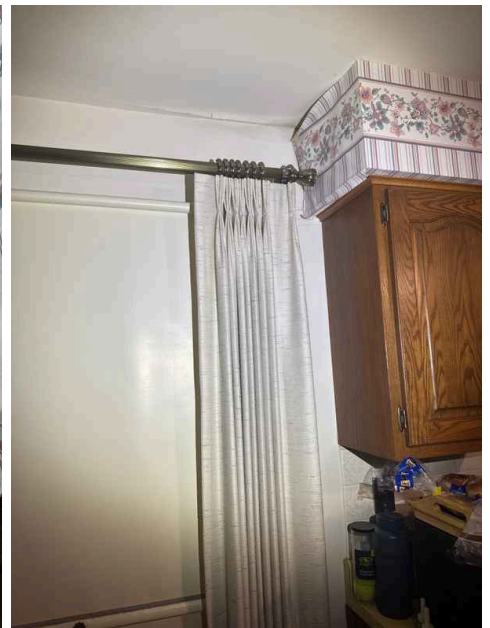
15.10.1 Floors, Walls, Ceilings

MOISTURE DAMAGE AT WALLS

Stains were observed on the walls that appeared consistent with moisture intrusion. The source of moisture may have been corrected prior to the inspection, but this could not be confirmed. Further evaluation by a qualified contractor is recommended to confirm the condition and perform any necessary repairs.

Contact a qualified professional.

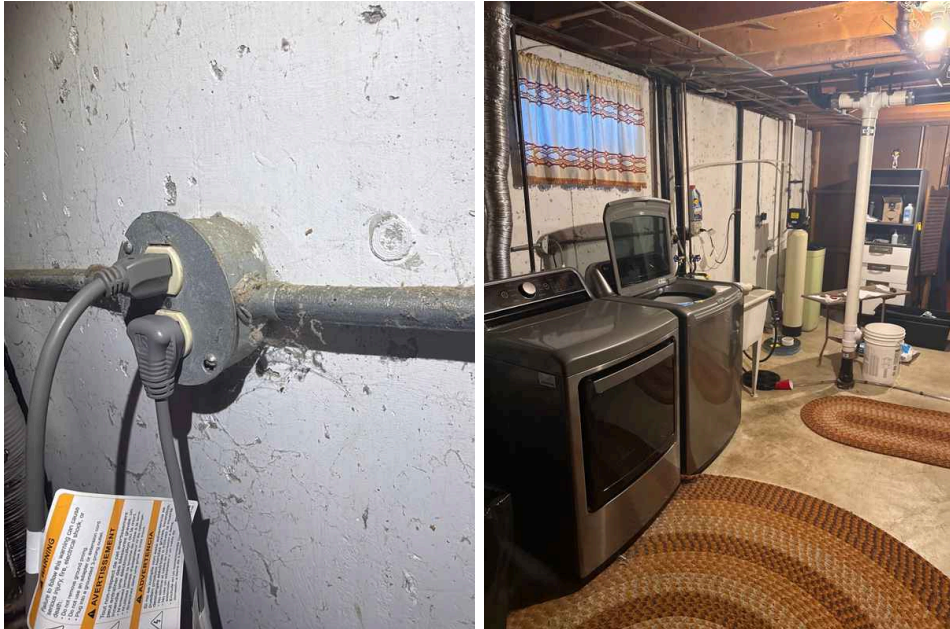
16.1.1 Laundry Room, Electrical, and Utility Sink

MISSING GFCI PROTECTION - LAUNDRY ROOM

GFCI protection was missing at the receptacles in the laundry room. Current electrical standards (NEC 210.8(A) (10) & 210.12(A), 2014 edition) require all 120-volt, 15- and 20-amp laundry room receptacles to be both GFCI- and AFCI-protected. Installation of compliant GFCI/AFCI protection by a qualified electrician is recommended to reduce the risk of electrical shock and fire.

Contact a qualified electrical contractor.

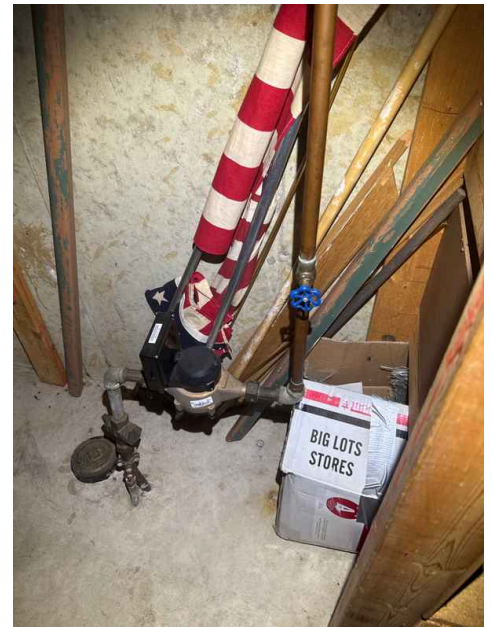
18.2.1 Water Supply Piping and Distribution

MISSING BONDING JUMPER

A bonding jumper cable was not observed at the water meter. Bonding jumpers are required to ensure continuous grounding of the electrical system. A missing bonding jumper presents a safety hazard. Installation by a qualified electrician is recommended.

Contact a qualified electrical contractor.

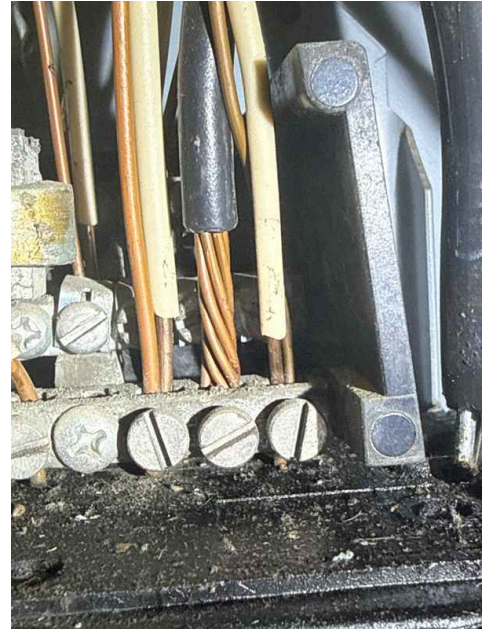
19.3.3 Panelboards and Breakers

DOUBLE-LUGGED NEUTRAL WIRES

Neutral wires were observed doubled under the same lug in the electrical panel. Each neutral wire should terminate under its own lug to ensure a secure and reliable connection. Double-lugged neutrals can loosen over time, leading to arcing or overheating. Correction by a licensed electrician is recommended.

Contact a qualified electrical contractor.

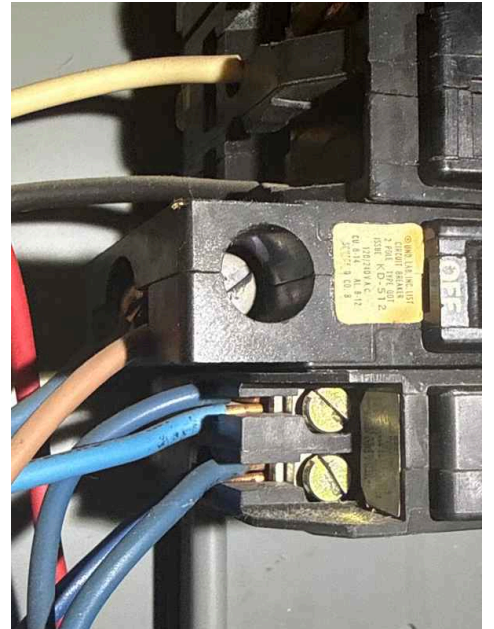
19.3.4 Panelboards and Breakers

DOUBLE-TAPPED HOT CONDUCTORS

Two hot conductor wires were observed connected to a single breaker, a condition commonly referred to as a "double tap." Standard breakers are designed for only one conductor, and double-tapping can result in loose connections, overheating, or arcing. Correction by a licensed electrician is recommended.

Contact a qualified electrical contractor.
