## INSPECTION REPORT BY D.A. INSPECTIONS

1234 Main Street  
Rockford, IL 61101

Buyer Name  
05/22/2026 9:00AM

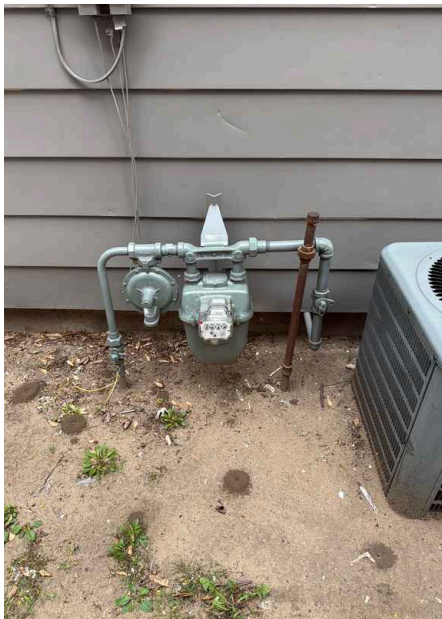
The main gas shutoff valve was located at the exterior gas meter.

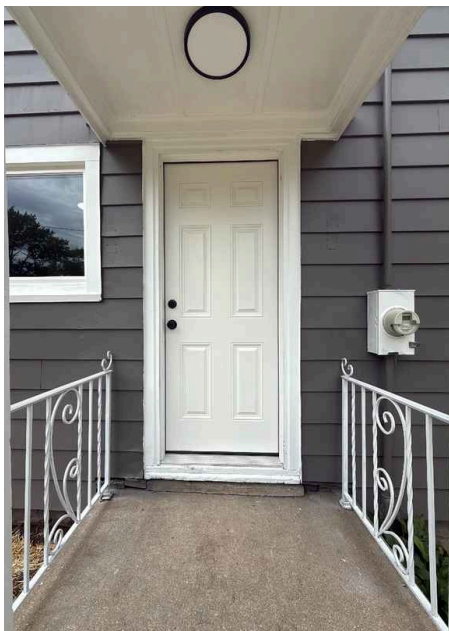
### Openings (Windows & Doors): Exterior Doors Inspected

A representative number of exterior doors were inspected. The inspection included evaluation of the doors' operation and overall condition as observed at the time of inspection.

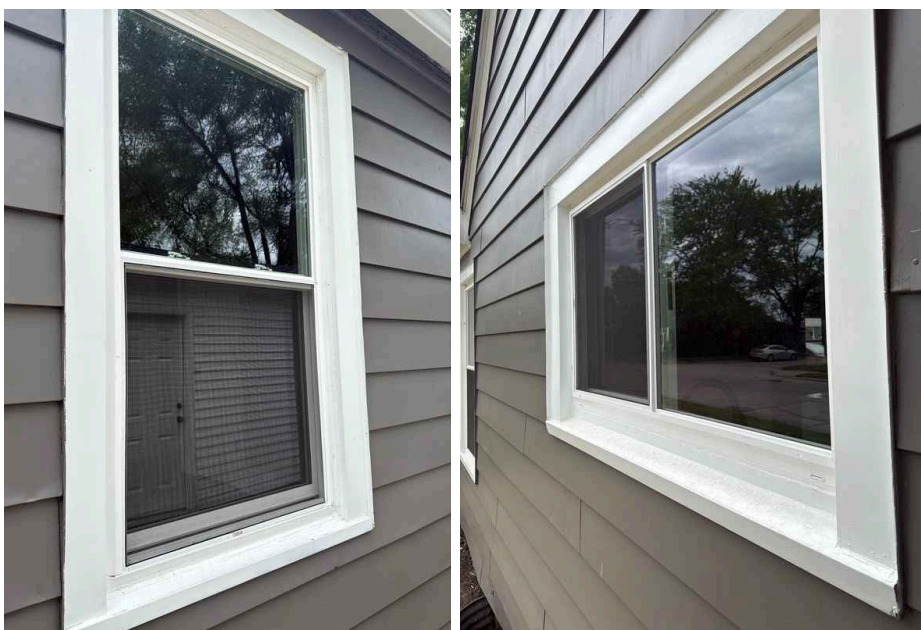
### Openings (Windows & Doors): Windows Inspected

A representative number of windows were inspected from the interior and ground level exterior. Inspection was limited to readily accessible and visible components.

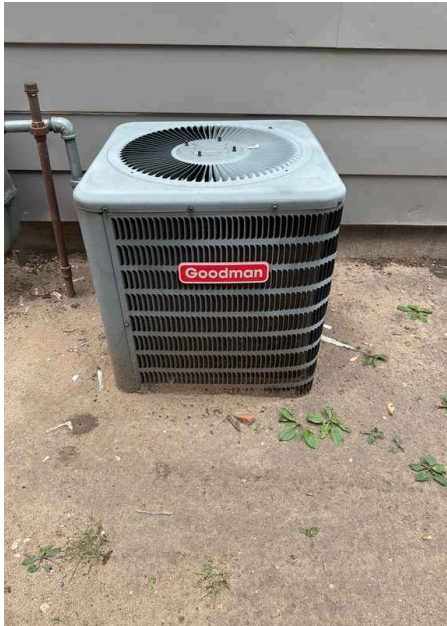
## Exterior Systems (AC/Electrical): Manufacturer - AC Unit

Goodman

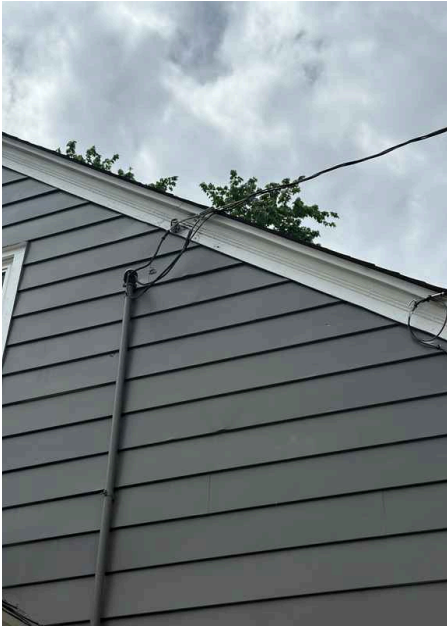
## Exterior Systems (AC/Electrical): Exterior Electrical Service Components Inspected

Visible exterior electrical service components were inspected, including the service drop, overhead conductors, attachment point, service head, and visible service mast or raceway components where present. Inspection was limited to visible and readily accessible components at the time of inspection.

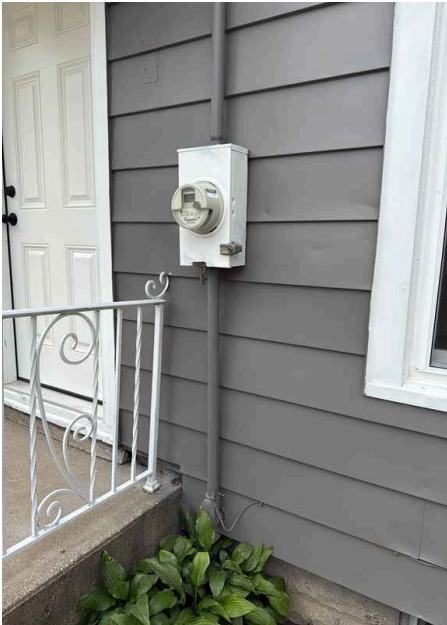
### Exterior Systems (AC/Electrical): Electrical Meter and Base Inspected

The visible electrical meter and meter base were inspected. Inspection was limited to visible exterior components and did not include concealed wiring or utility-owned components.

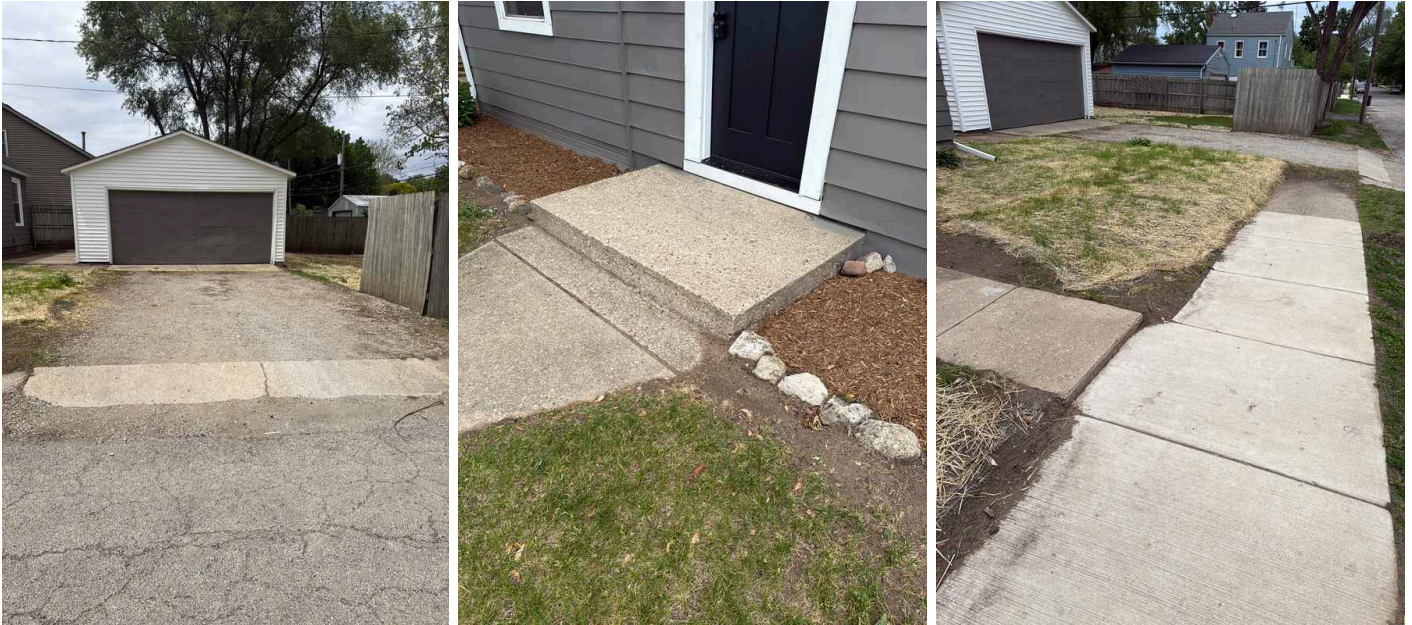
### Walkways and Access: Walkways & Driveways Were Inspected

Walkways and driveways were inspected visually and where accessible. Walkways and driveways are critical exterior hardscape elements that provide access, circulation, and aesthetic value to residential properties. These surfaces are typically constructed from materials like concrete, asphalt, pavers, brick, or gravel and serve functional transportation purposes while contributing to overall property landscaping. Proper installation, maintenance, and periodic inspection are essential for ensuring safe, durable, and visually appealing pedestrian and vehicular pathways around a home.

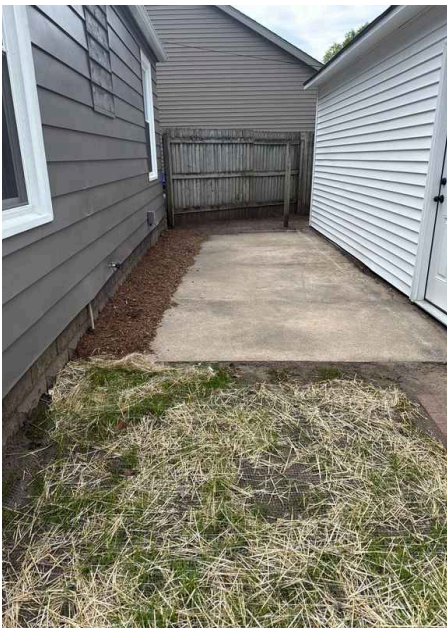
### **Decks / Porches / Railings: Porches, Patios, Decks, and Balconies Were Inspected**

The porches, patios, decks, and balconies at the property were inspected where accessible and visible. This inspection was not a code compliance inspection, but home inspectors may refer to code guidelines to help identify potential safety or performance concerns. Structures that are a few years old may not meet current code standards, and that's expected. The focus of the inspection is to identify visible defects or conditions that may impact safety, stability, or contribute to water intrusion.

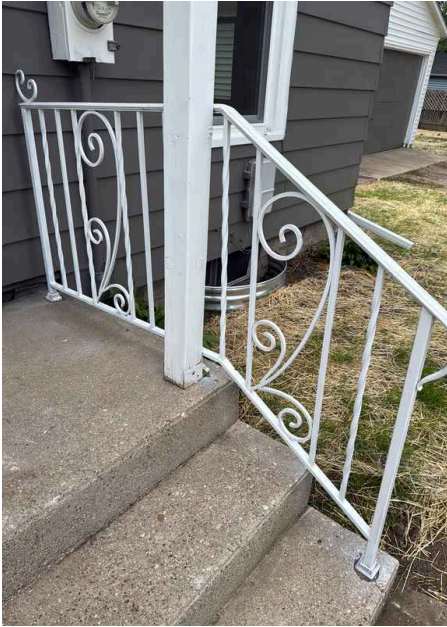
### **Decks / Porches / Railings: Railings, Guards & Handrails Were Inspected**

Railings, guards, and handrails are essential safety components in residential structures, designed to prevent falls and provide support during movement between levels or along stairs. These architectural elements serve multiple purposes, including fall protection, structural support, and accessibility assistance. Proper installation, maintenance, and compliance with local building codes are critical for ensuring occupant safety and preventing potential injuries. Railings can be constructed from various materials such as wood, metal, glass, or composite materials, each offering different aesthetic and functional characteristics.

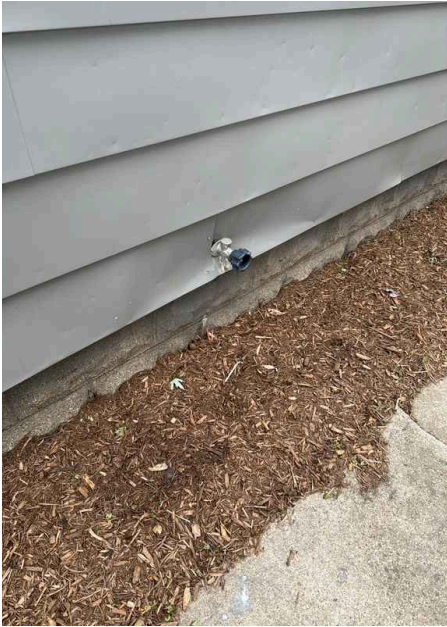
### Hose Bibs / Exterior Faucets: Hose Bibs Inspected

Exterior hose bibs were inspected where present. Inspection included operation using normal controls and observation for visible leaks or defects.

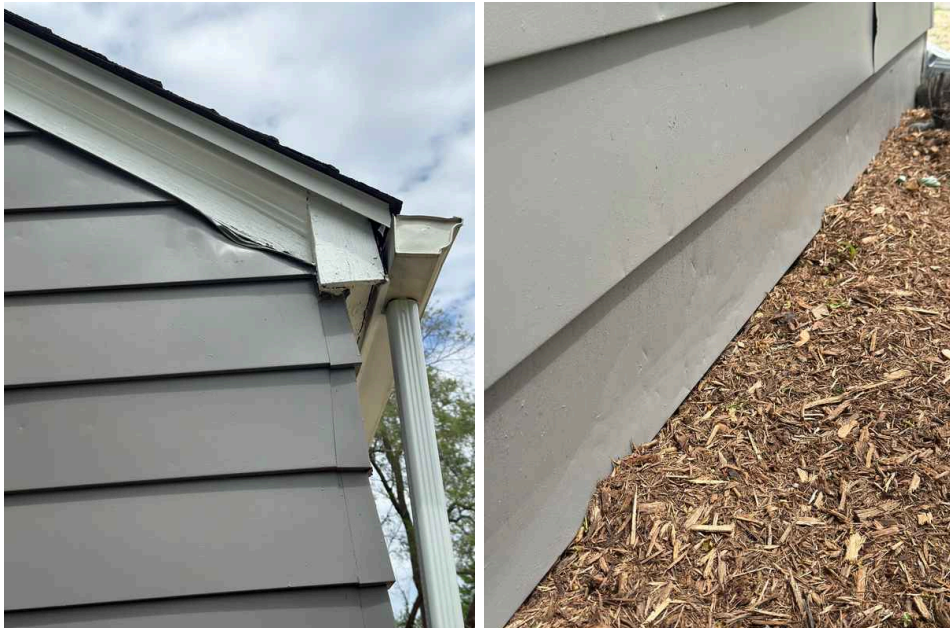
### DAMAGED WALL-COVERING MATERIAL

**Minor damage to the exterior wall covering material was observed.** The condition appeared cosmetic in nature at the time of inspection and no significant indications of active water intrusion were observed in the affected area. Monitoring and repair as needed for cosmetic improvement and to help maintain the exterior surface is recommended.

Contact a qualified professional.

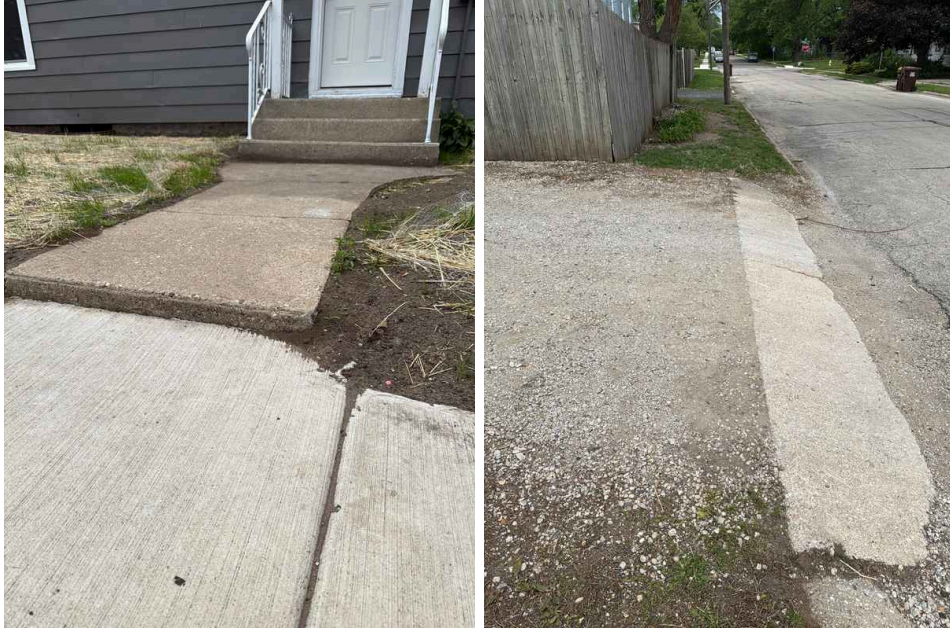
**TRIP HAZARD AT STEP**

**A trip hazard was observed on the exterior steps during the inspection.** The uneven surface or height difference between steps creates a fall risk for anyone using the stairs. This condition could lead to potential injuries, especially for elderly individuals or those with mobility challenges. Professional evaluation and repair of the step surface or height discrepancy is recommended to ensure safe passage.

Contact a qualified general contractor.

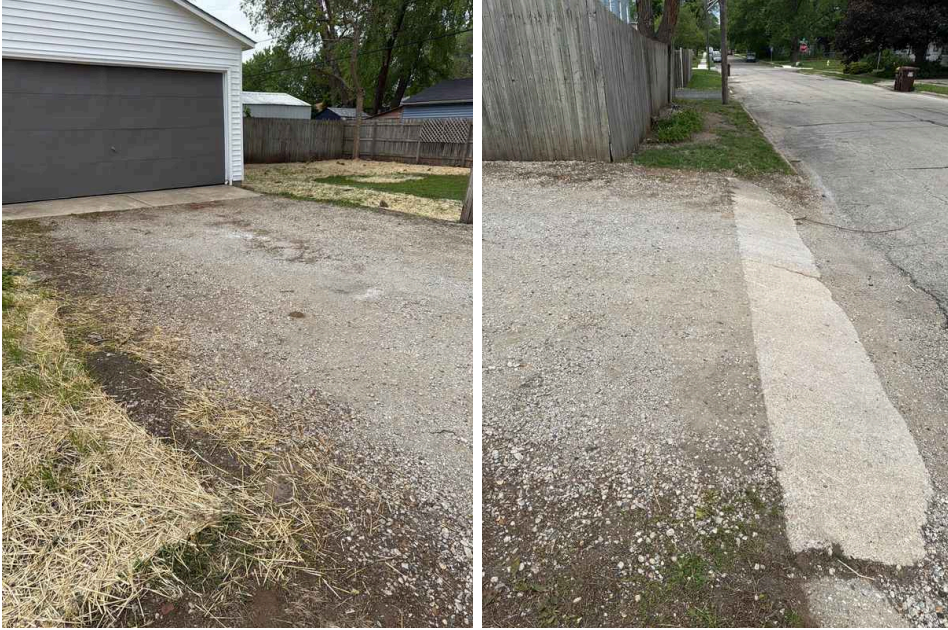
## 2.5.2 Walkways and Access

**The driveway surface consisted of loose rock/gravel and appeared unfinished at the time of inspection.** This condition is generally considered a cosmetic or convenience-related item but may require periodic maintenance to help manage surface displacement and rutting. Improvements or surface upgrades may be considered as desired.

Contact a qualified professional.

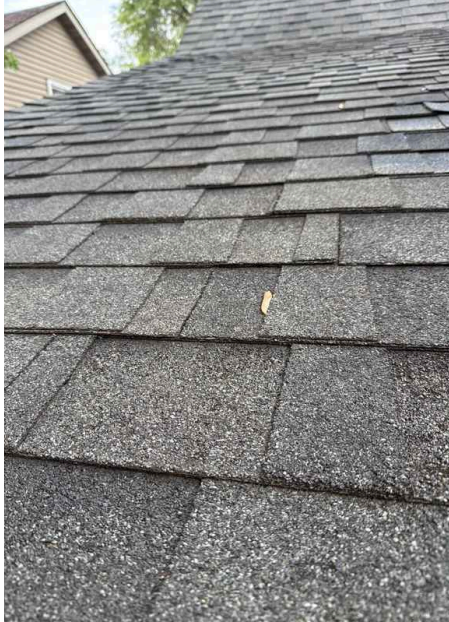
The roof covering material was observed and its type identified when possible. Many styles, brands, and materials exist, each with specific installation requirements beyond the scope of this inspection.

This was a general, visual inspection only. Every effort was made using professional judgment to identify and report any defects.

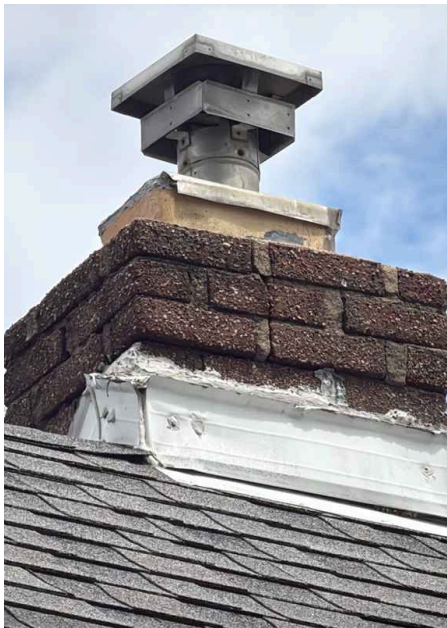
### Penetrations & Components: Masonry Chimney Exterior Was Inspected

The exterior of the masonry chimney was inspected. Masonry chimneys typically require ongoing maintenance due to their exposure to weather and environmental stress. Over time, cracks can develop in the mortar joints, increasing the potential for water intrusion. Moisture within the masonry can freeze and lead to surface deterioration (spalling). Chimney components such as rain caps and screens may become damaged, loose, or corroded. This was a visual-only inspection conducted to the best extent possible using the tools and access available at the time of inspection.

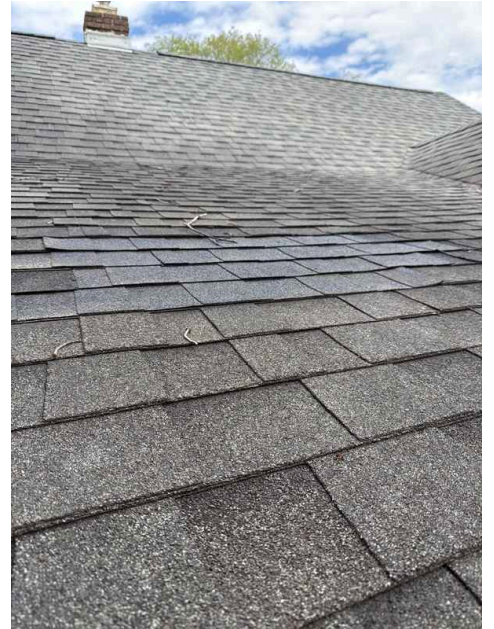
**DISCOLORATION STAIN FROM ALGAE**

Minor Defect

Contact a qualified roofing professional.

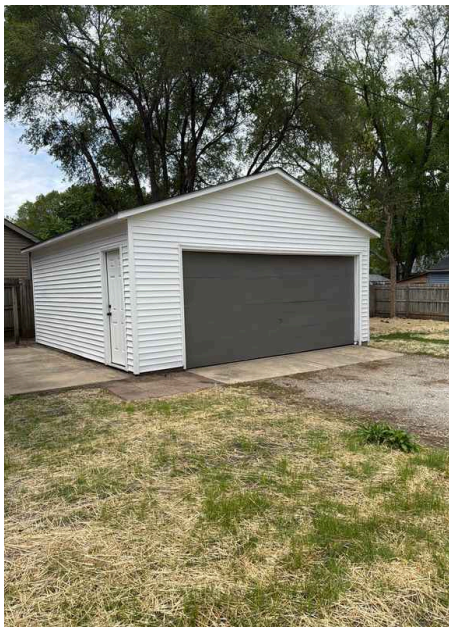
### Detached Garage Information

A detached garage was present at the property. The structure was inspected where accessible. Components such as the structure, garage door, and visible electrical were evaluated at the time of inspection.

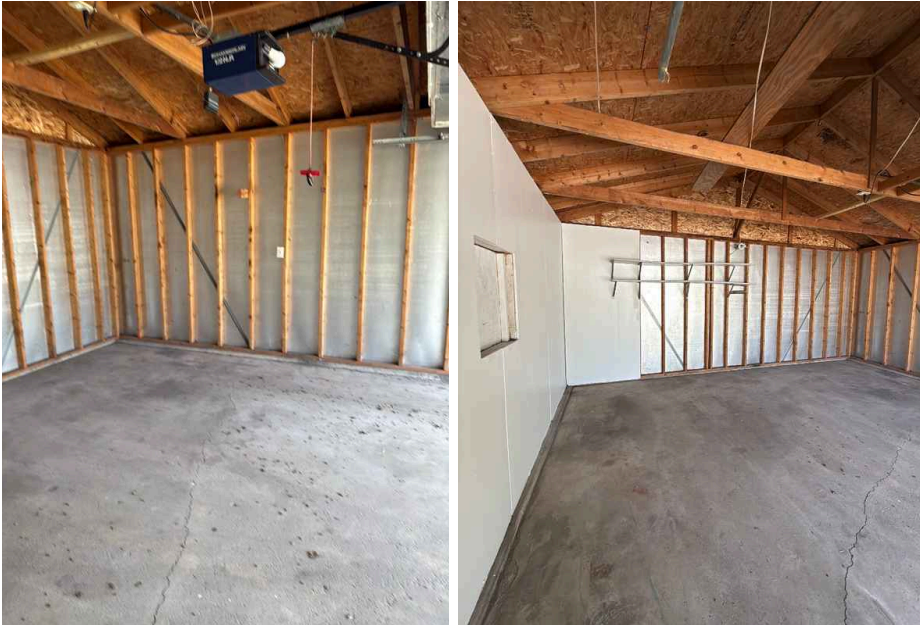
### Garage Structure & Components: Garage Ceiling and Walls Inspected

The ceiling and walls of the garage were inspected in accordance with the Home Inspection Standards of Practice. Readily visible surfaces were evaluated for signs of damage, deterioration, or safety concerns.

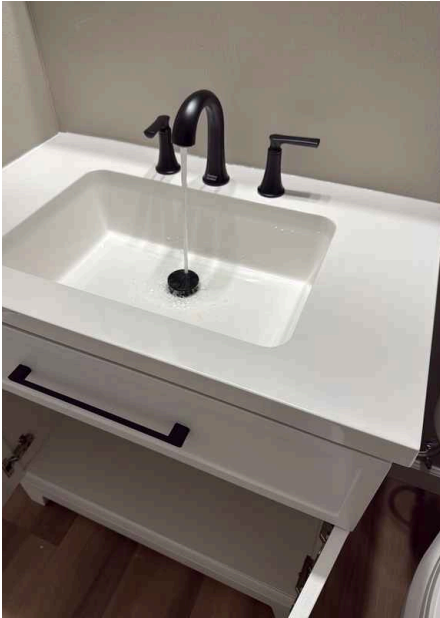
#### Toilet: Toilet Inspected

The toilet was inspected using normal operating controls.

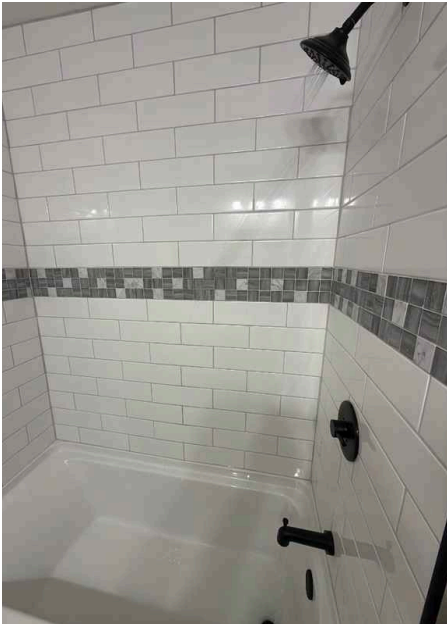
### **Tub and Shower: Tub and Shower Inspected**

The tub and shower were inspected using normal operating controls where present.

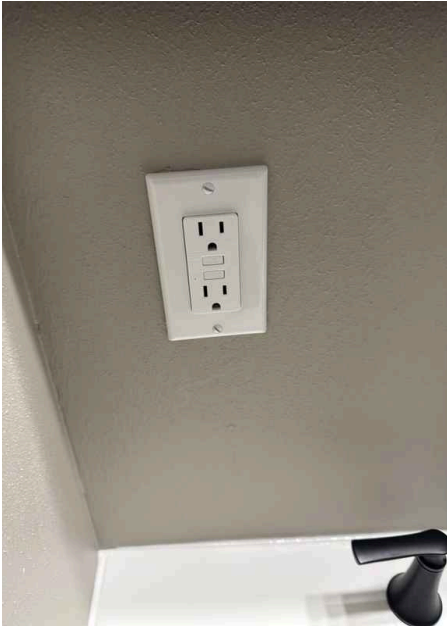
### **Switches, Fixtures, Receptacles, and GFCI Protection: Switches, Fixtures, Receptacles, and GFCI Protection Inspected**

Accessible switches, light fixtures, receptacles, and GFCI protection were inspected.

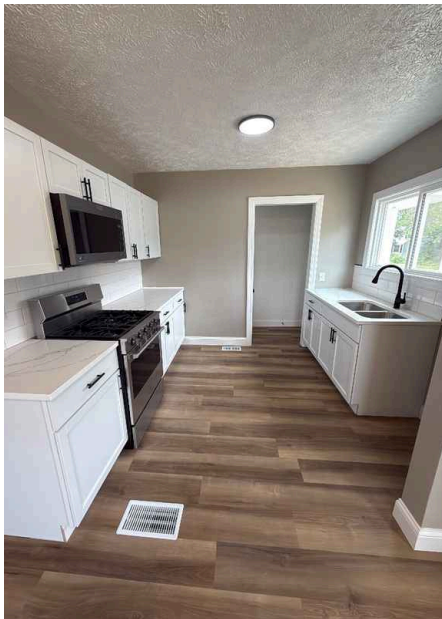
### Countertops and Cabinets: Countertops and Cabinets Inspected

Visible countertops and cabinets were inspected.

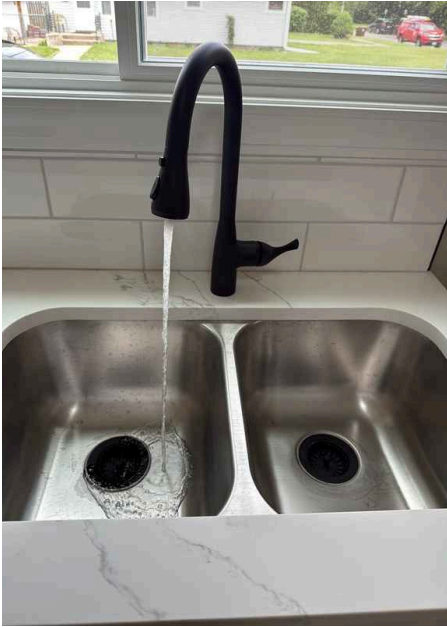
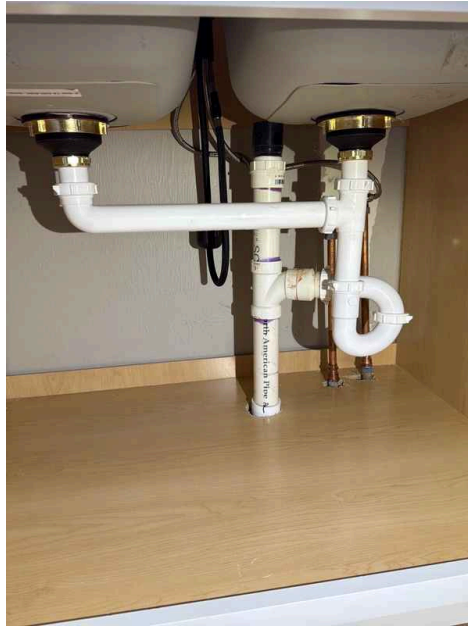
### Kitchen Sink and Plumbing: Kitchen Sink and Plumbing Inspected

Water was run at the kitchen sink to verify basic operation. This action was performed as a courtesy and is beyond the scope of a home inspection. The kitchen sink, faucet, and visible plumbing components were inspected.

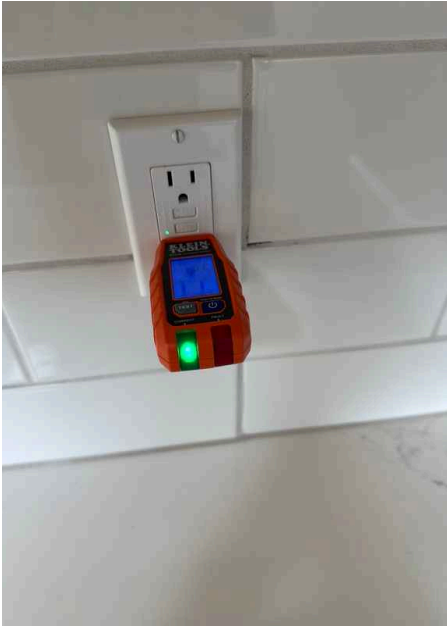
### Switches, Fixtures, Receptacles, and GFCI Protection: Switches, Fixtures, Receptacles, and GFCI Protection Inspected

Accessible switches, light fixtures, receptacles, and GFCI protection were inspected.

Ground fault circuit interrupter (GFCI) protection were observed and tested in the kitchen. GFCI devices are designed to reduce the risk of electrical shock in wet areas, while arc fault circuit interrupter (AFCI) devices help protect against electrical fires by detecting arcing faults. Testing was performed using the device test button or a testing instrument.

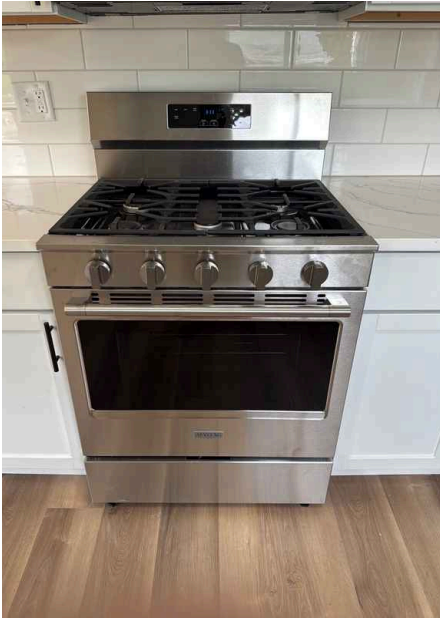
### Range, Oven, and Cooktop: Range/Oven Manufacturer

Maytag

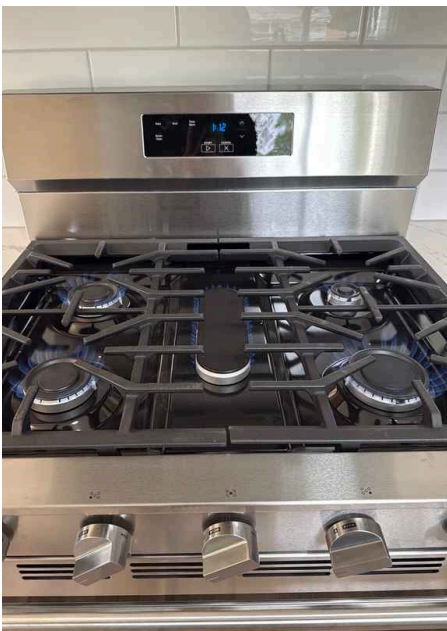
### Range, Oven, and Cooktop: Range and Oven Operation

The kitchen range and oven were briefly turned on to verify response to operator controls. This action was performed as a courtesy and is beyond the scope of a home inspection. A full cooking cycle was not conducted, and appliance performance under normal use was not evaluated.

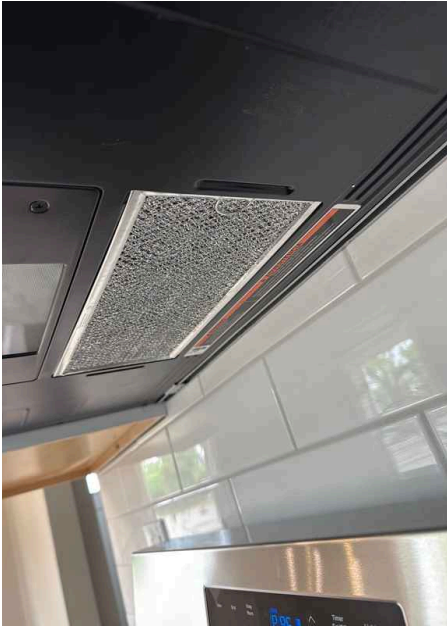
### Exhaust Fan / Ventilation: Kitchen Exhaust Fan Inspection

The kitchen exhaust fan was inspected. All mechanical exhaust fans should terminate to the exterior of the home. Confirming proper termination is beyond the scope of a home inspection; however, as a courtesy, efforts were made to identify whether the fan exhausts outside.

In some cases, exhaust fans and over-range microwave exhaust systems are configured to recirculate air back into the kitchen rather than vent outside. These systems rely on filters that should be cleaned or replaced regularly to maintain performance. The fan or microwave exhaust was briefly turned on to verify operation, and the condition of accessible filters was observed where possible.

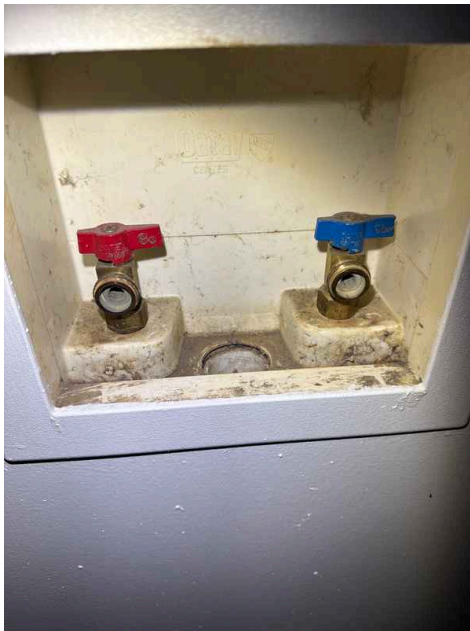
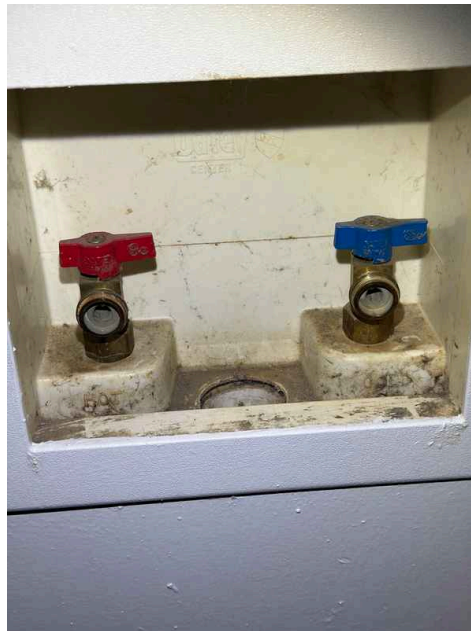
The clothes washer was not operated during the inspection. Operation of laundry appliances is beyond the scope of a home inspection, although they may occasionally be tested as a courtesy. No determination of functionality was made at this inspection.

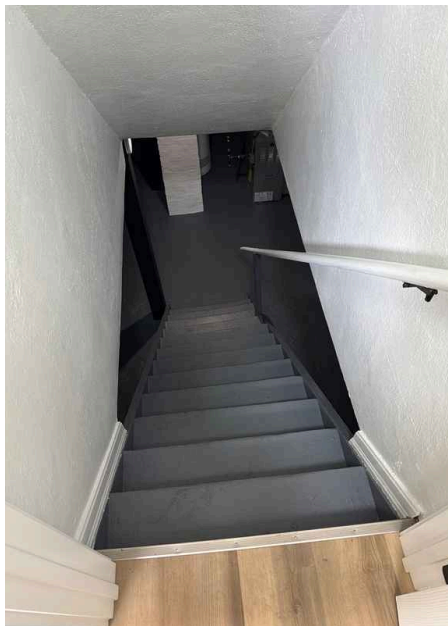
### Basement / Crawlspace / Structure Overview

The basement, crawlspace, and visible structural components were inspected where accessible. Inspection included observation of the foundation, floor structure, wall structure, support components, and visible conditions at the time of inspection.

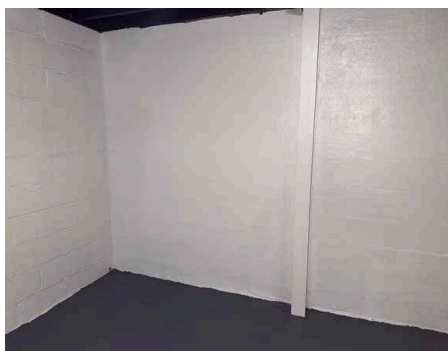
### Foundation: Type of Foundation Described

Basement, Masonry Block

The foundation type and construction materials were identified to the extent possible. Some homes may have multiple foundation types due to renovations, additions, or modifications.

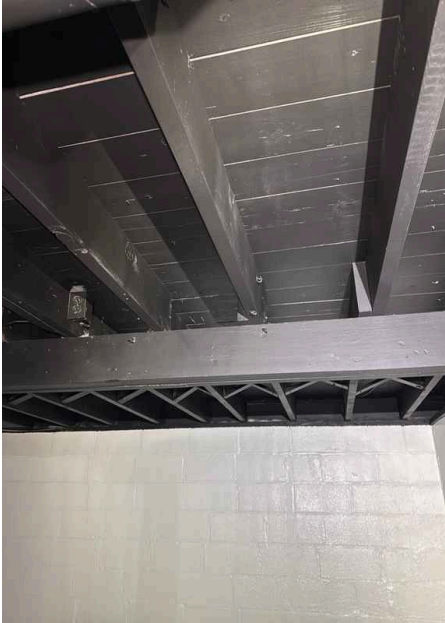
### Visible Structural Components: Structural Components Were Inspected

Structural components were inspected according to the [Home Inspection Standards of Practice](#), including readily observed floor joists.

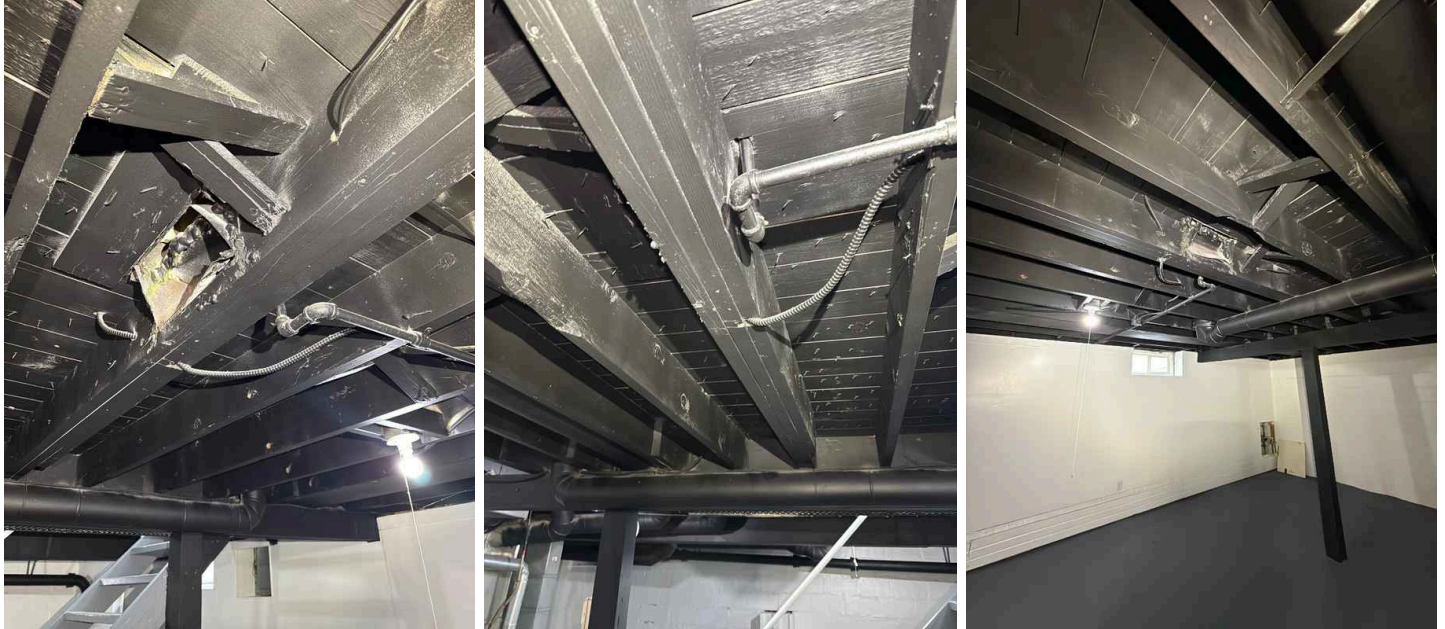
**A floor joist appeared to have been previously cut or altered at the time of inspection.** Additional support framing had been installed in the affected area, and no significant movement or distress was observed at the time of inspection. The repair method appeared functional; however, concealed conditions cannot be determined during a visual inspection. Monitoring and further evaluation by a qualified contractor may be considered if concerns develop.

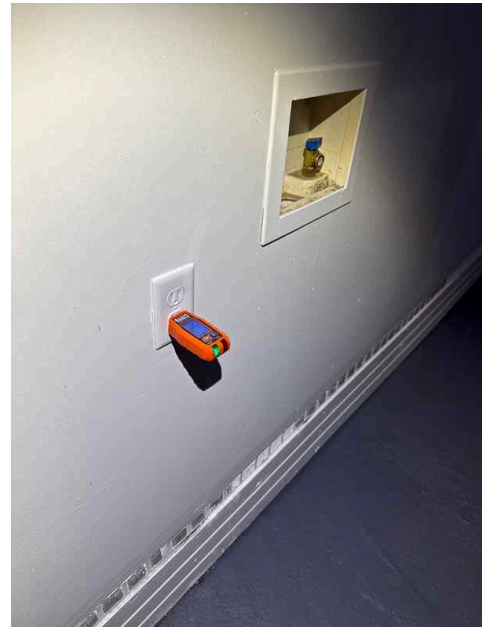
## 16.5.1 Basement Electrical / GFCI Protection

**Ground-fault circuit interrupter (GFCI) protection was not observed at basement electrical receptacles at the time of inspection.** Modern safety standards commonly recommend GFCI protection in basement areas to reduce the risk of electrical shock. Upgrading affected receptacles to GFCI protection by a qualified electrician is recommended as a safety improvement.

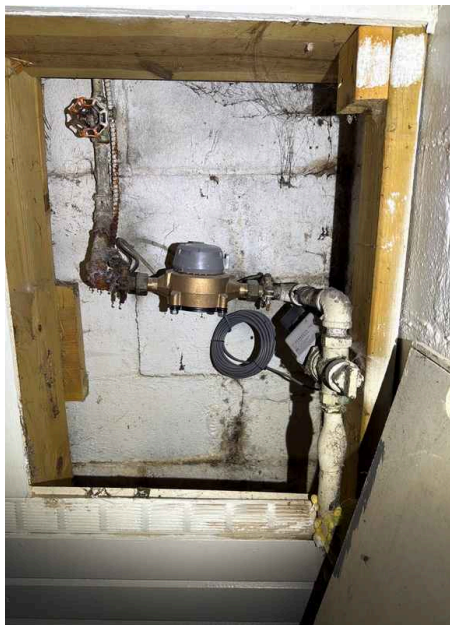
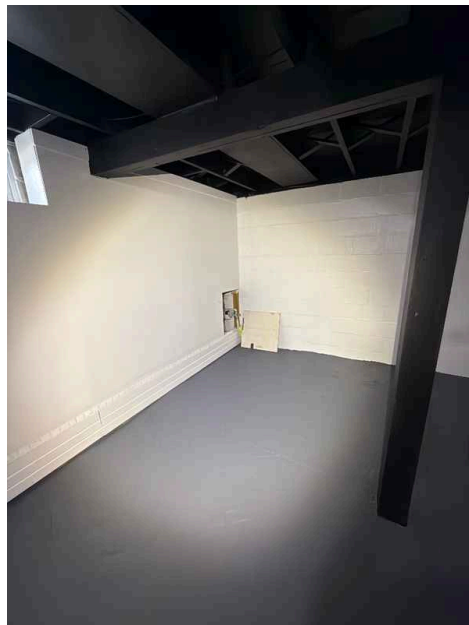
### Location of Main Water Shut-Off Valve

Basement

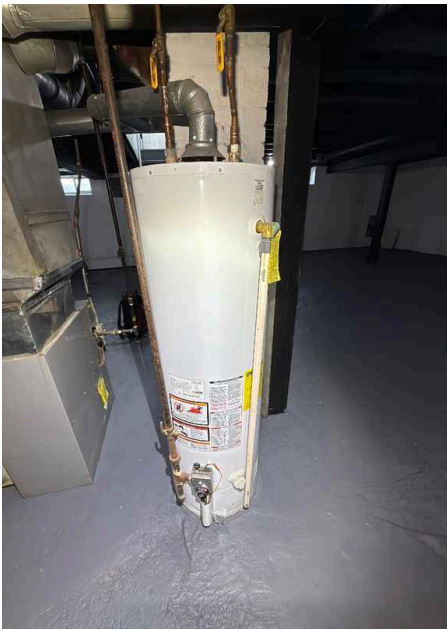
The manufacturer of the water heater was identified. Annual flushing and servicing of the tank are recommended to maintain optimal performance and extend service life. **Water temperature should be set to at least 120°F to reduce**

the risk of microbial growth and no higher than 130°F to minimize the risk of scalding.

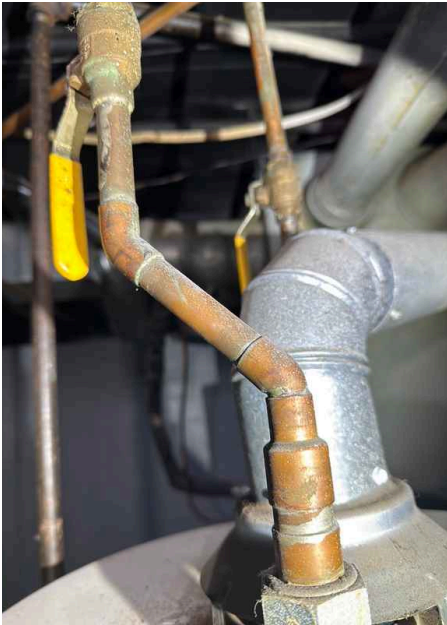
### **Water Supply Piping and Distribution: Water Supply Piping and Distribution Inspected**

The water supply and distribution piping was inspected where accessible. Portions of the system were not visible due to obstructions or finished surfaces, which limited the inspection. Verification of past performance, including any history of supply problems or leaks, should be obtained from the homeowner.

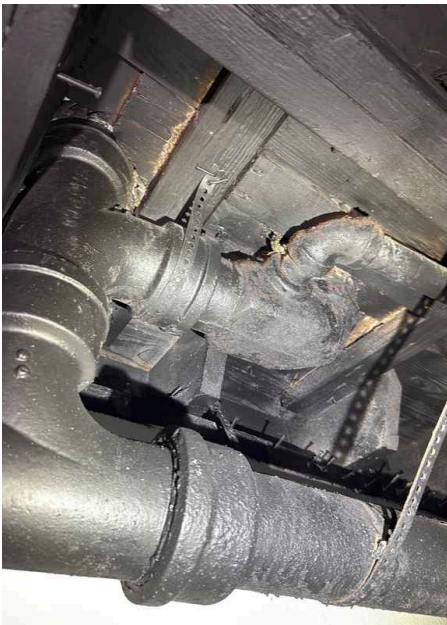
### **Drain, Waste, & Vent Systems: Drain, Waste, Vent Pipes Inspected**

The drain, waste, and vent (DWV) piping was inspected where accessible. Portions of the system were not visible due to finished surfaces or other obstructions, which limited the inspection. Confirmation of past performance, including any history of leaks or blockages, should be obtained from the homeowner.

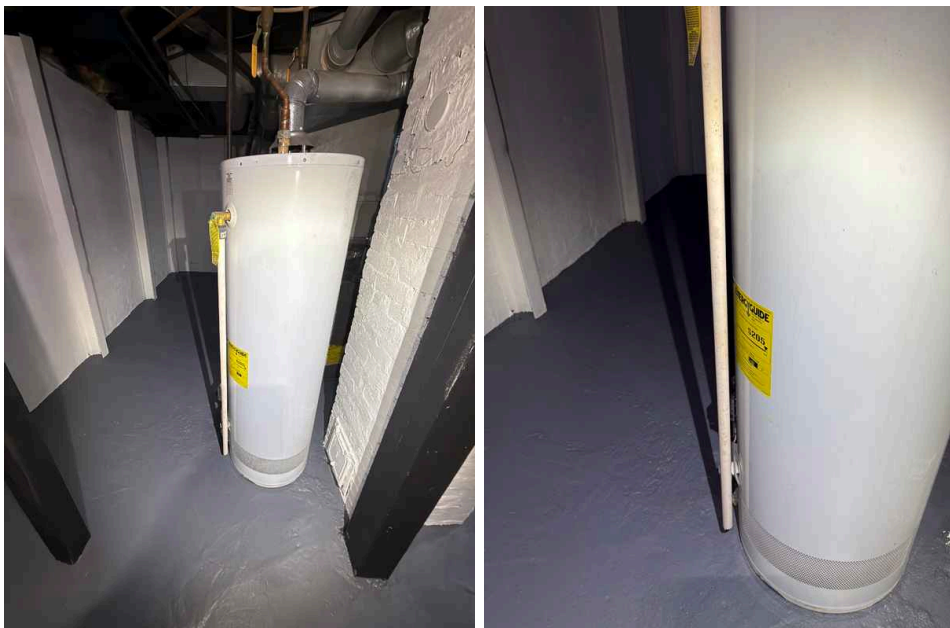
The temperature and pressure relief (TPR) valve discharge pipe did not terminate at an appropriate drain or discharge location at the time of inspection. Improper termination may allow water discharge in a manner that could cause damage or create a safety concern if the valve activates. Correction by a qualified plumbing contractor is recommended.

Contact a qualified plumbing contractor.

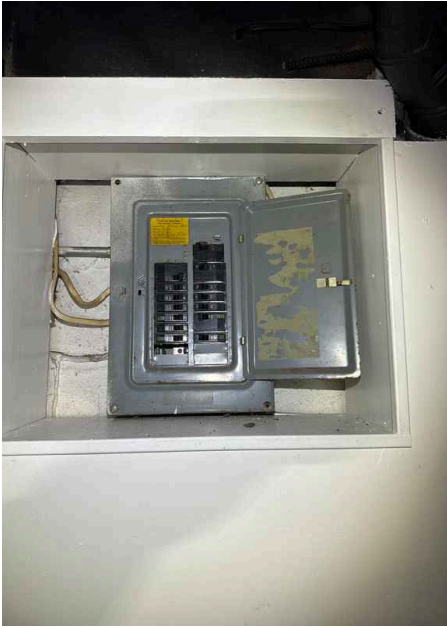
### Service-Entrance Conductors: Service-Entrance Conductors Inspected

The electrical service-entrance conductors were inspected where visible and accessible. The inspection was limited to observable conditions at the time of inspection.

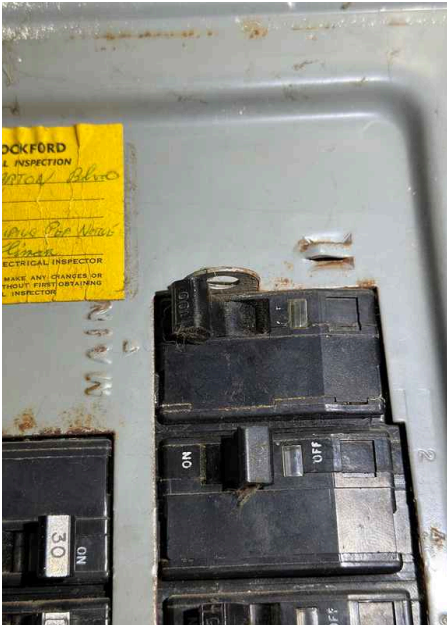
### Main Service Disconnect: Main Service Disconnect Inspected

The electrical main service disconnect was inspected where visible and accessible. The inspection was limited to observable conditions at the time of inspection.

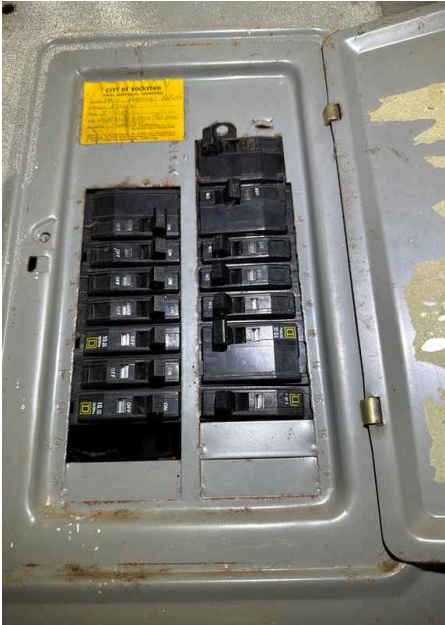
### Panelboards and Breakers: Main Panelboard and Breakers Inspected

The electrical panelboards and breakers were inspected where accessible. Inspection included visible components, overcurrent protection devices, and evaluation of AFCI and GFCI protection where present.

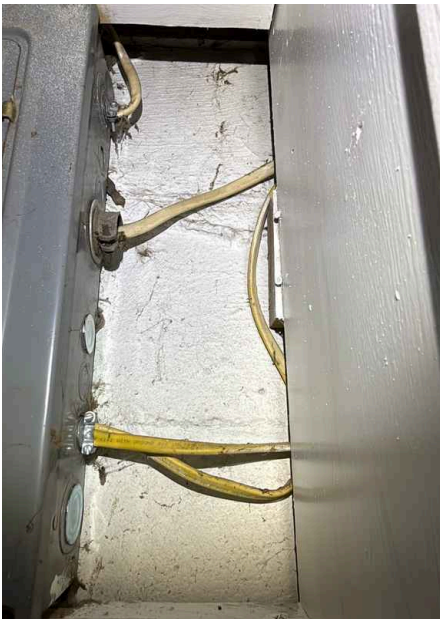
**Branch Wiring: Type of Wiring, If Visible**

Visible branch wiring was inspected where accessible. Inspection was limited to visible wiring and readily accessible components at the time of inspection.

NM-B (Romex)

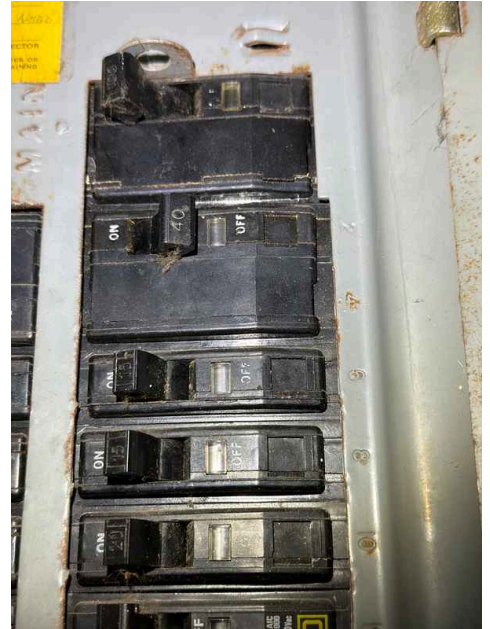
A breaker was observed in the "off" position prior to inspection of the electrical panel. The connected circuit could not be evaluated as a result. The homeowner should be asked what this breaker serves and why it was off at the time of inspection.

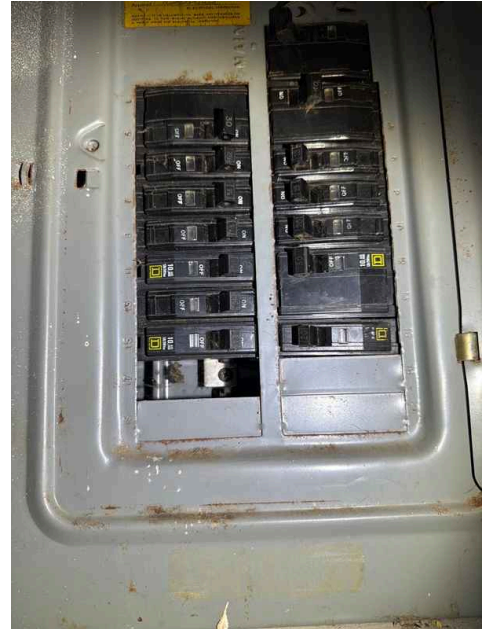
**OPEN BREAKER KNOCKOUT (FILLER PLATE MISSING)**

**An unused circuit-breaker panel opening was observed without a filler plate installed.** Missing filler plates expose live electrical components, presenting a serious shock hazard. Correction by a licensed electrician is recommended.

Contact a qualified electrical contractor.

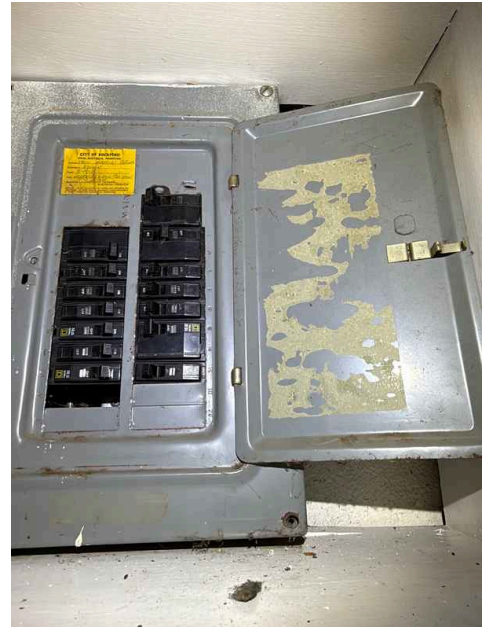
**MISSING IDENTIFICATION OF DISCONNECTS AT PANEL**

**The electrical panel was observed with missing or inadequate identification of individual circuits.** Each circuit should be clearly labeled to indicate its purpose, and no two circuits should share the same label. Proper labeling improves safety and facilitates service. Correction by a licensed electrician is recommended.

Contact a qualified electrical contractor.

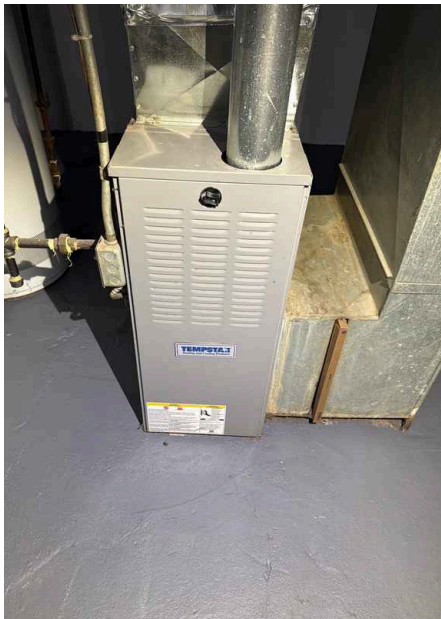
### Manufacturer

TEMPSTAR

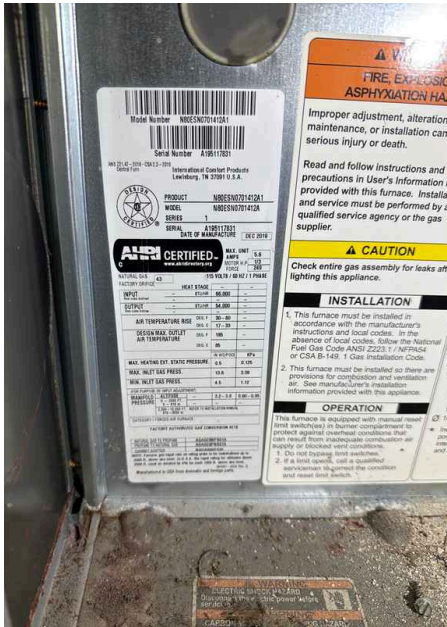
### Manufactured Date

2019

According to InterNACHI, the typical service life of a furnace is approximately **15 to 25 years**. Systems beyond this age may experience reduced efficiency, increased repair needs, and higher risk of failure. Regular maintenance is recommended to prolong service life. For more information, see: [InterNACHI's Standard Estimated Life Expectancy Chart for Homes](#)

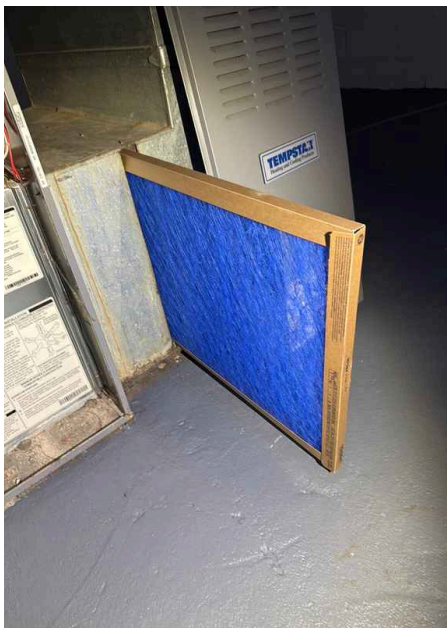
16x25x1

Air filters should generally be checked every 1–3 months and replaced as needed. Regular replacement helps maintain system efficiency, indoor air quality, and prolongs the life of the heating system.

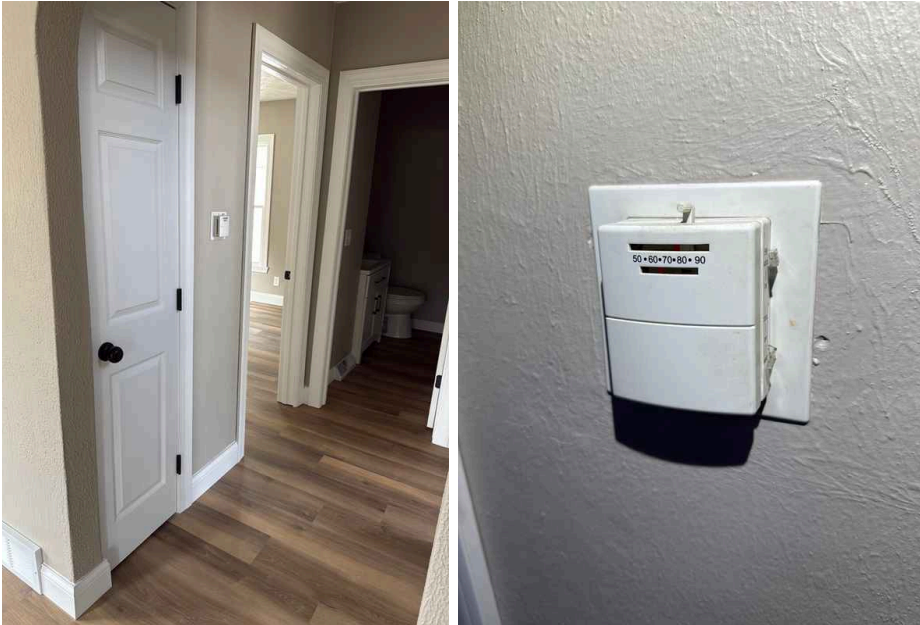
**Thermostat: Thermostat Location**

First floor

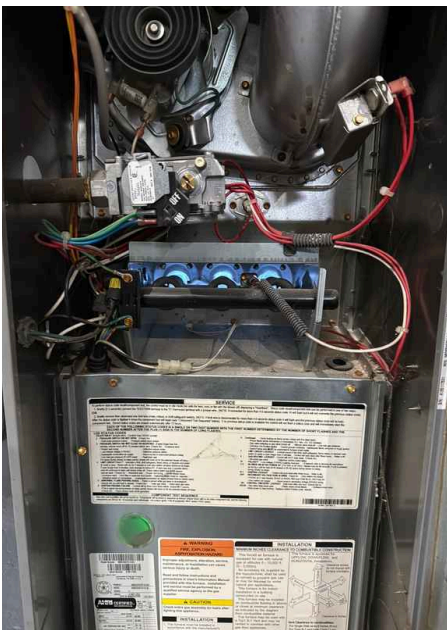
### **Heating Equipment: Heating Equipment Inspected**

The heating equipment was inspected where visible and accessible. The system was operated using normal operating controls, and accessible components such as the cabinet, burners, heat exchanger area (where visible), and filter were observed. The inspection included a general evaluation of system condition and performance at the time of inspection. This is not a comprehensive or invasive evaluation, and internal or concealed components were not fully inspected.
