## INSPECTION REPORT BY D.A. INSPECTIONS

1234 Main Street  
Rockford, IL 61101

Buyer Name  
05/22/2026 9:00AM

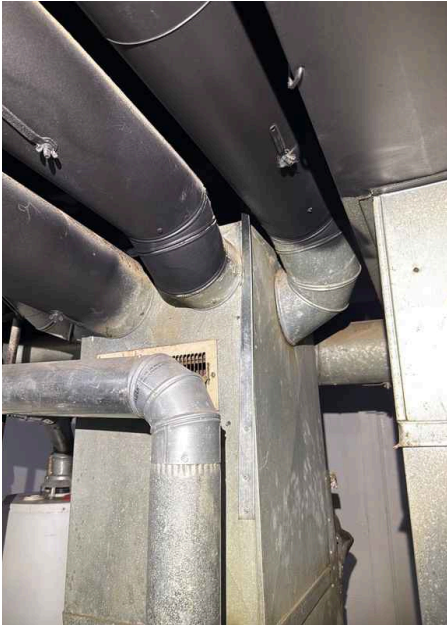
### **Distribution System: Distribution System Inspected**

The heating distribution system was inspected where visible and accessible. This included ductwork, registers, radiators, or baseboard heating components where present. Inspection included observation for visible damage, disconnections, obstructions, and general airflow or heat distribution at the time of inspection.

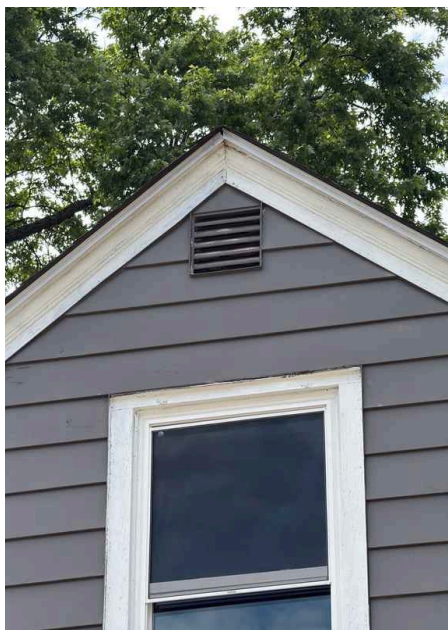
### Attic Inspection Information

The attic area was inspected where accessible. Visible attic components were reviewed, including roof framing, roof sheathing, insulation, ventilation, and visible mechanical exhaust components where present.
