SUMMARY
 1234 Main Street Rockford IL 61101
 Buyer Name
 06/15/2026 9:00AM

Dan Aranki
 IL License No. 450.013334, interNACHI
 Certified Professional Inspector®
 D.A. Inspections
 (815) 765-4324
info@da-inspections.com

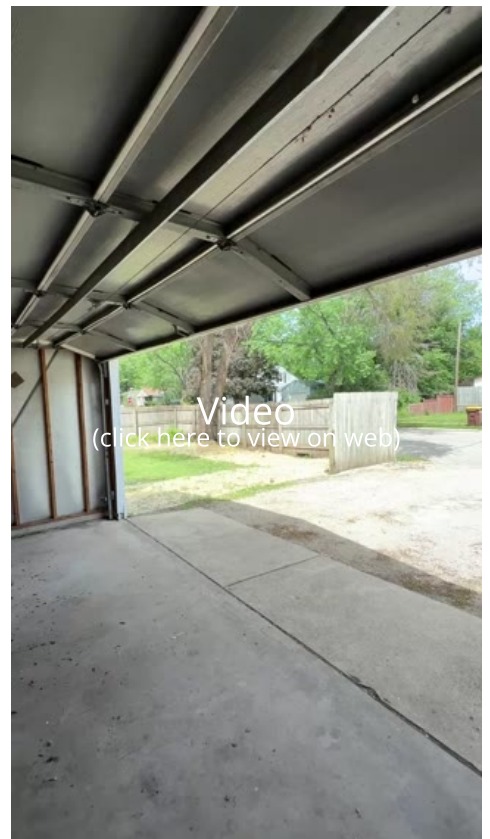
4.2.1 Garage Door & Opener

DETACHED GARAGE DOOR OPERATION CONCERN

The detached garage overhead door opener activated at the time of inspection; however, the door appeared to bind or jam during closing and did not close normally under powered operation. Manual operation using the emergency release function was possible at the time of inspection. The condition may be related to track alignment, hardware adjustment, or another operational issue. Evaluation and repair by a qualified garage door contractor is recommended. See attached video.

Recommendation
 Contact a qualified professional.

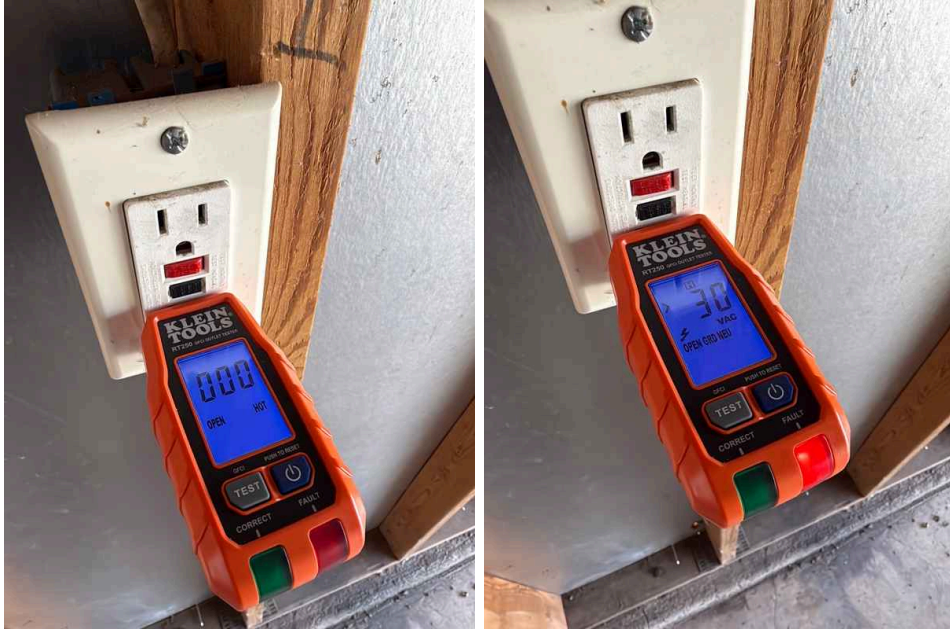
4.3.1 Garage Electrical

MISSING GFCI PROTECTION IN GARAGE

A receptacle in the attached garage was observed without ground-fault circuit interrupter (GFCI) protection. Current safety standards require GFCI protection for all 15- and 20-amp receptacles in garages, including outlets serving refrigerators, garage door openers, and washing machines. The absence of GFCI protection increases the risk of electrical shock. Installation of proper GFCI protection by a licensed electrician is recommended.

Recommendation

Contact a qualified electrical contractor.

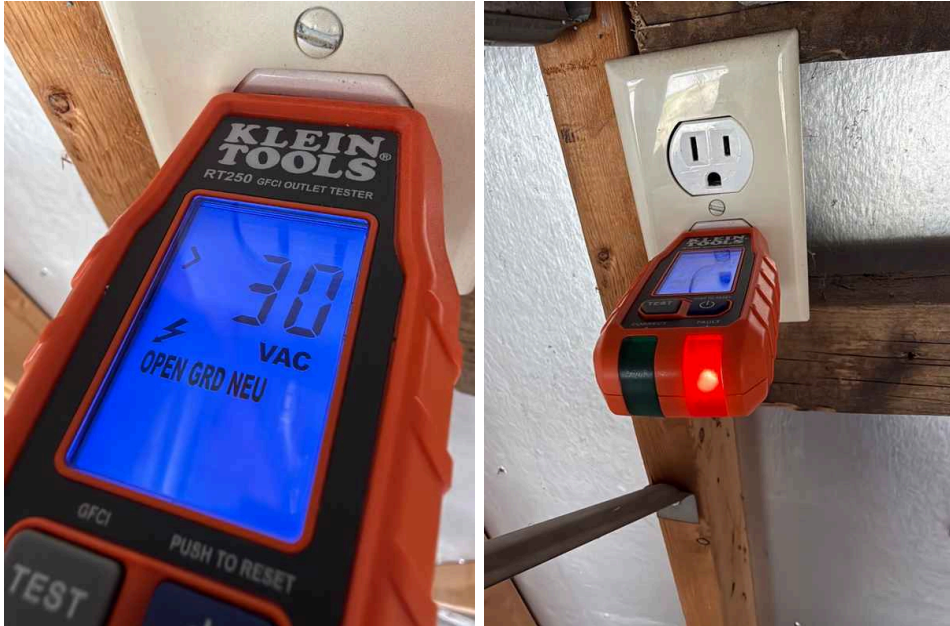
4.3.2 Garage Electrical

OPEN GROUND/OPEN NEUTRAL CONDITION AT GARAGE RECEPTACLE

An open ground/open neutral condition was indicated at a garage electrical receptacle during testing at the time of inspection. This condition may affect proper operation and safety of the receptacle and connected devices. Evaluation and repair by a qualified electrician is recommended.

Recommendation

Contact a qualified professional.

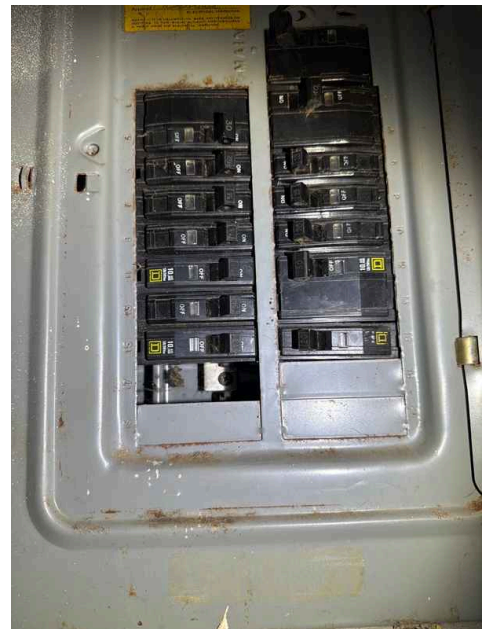
18.3.1 Panelboards and Breakers

OPEN BREAKER KNOCKOUT (FILLER PLATE MISSING)

An unused circuit-breaker panel opening was observed without a filler plate installed. Missing filler plates expose live electrical components, presenting a serious shock hazard. Correction by a licensed electrician is recommended.

Recommendation

Contact a qualified electrical contractor.
