INSPECTION REPORT BY D.A. INSPECTIONS

1234 Main Street
Rockford, IL 61101

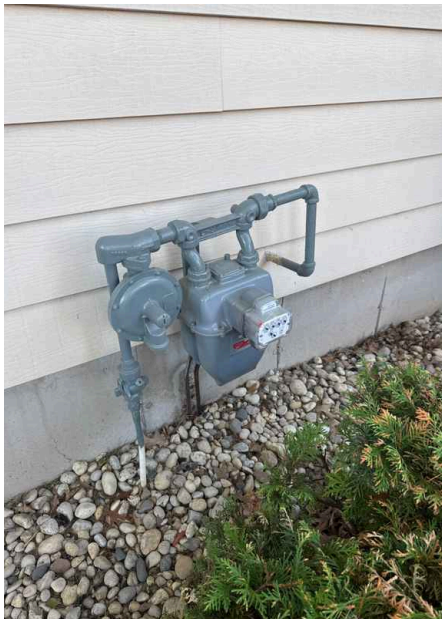
Side of House

The main gas shutoff valve was located at the exterior gas meter.

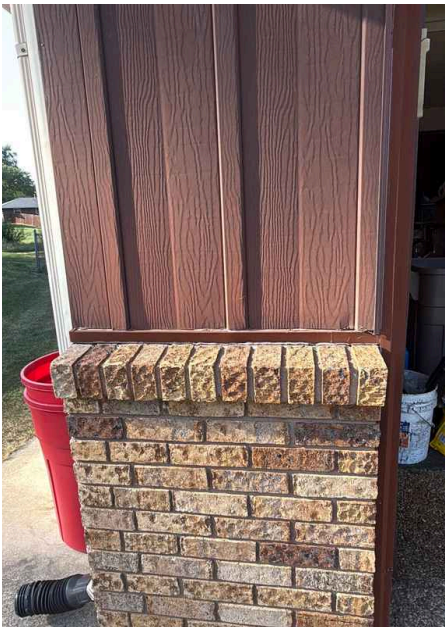
Wall Covering / Structure: Wall Covering Materials Inspected

The exterior wall-covering material was identified to the best extent possible during the inspection. Like all exterior components, the wall cladding is subject to gradual deterioration from exposure to sun, wind, rain, and temperature fluctuations.

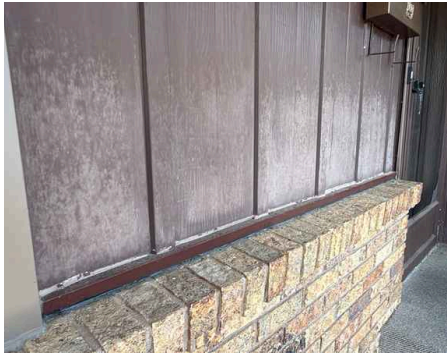
Wall Covering / Structure: Worn Out Areas of Exterior Wall-Covering

Indications of wear, aging, or deferred maintenance were observed at areas of the exterior wall-covering. These conditions may include fading, cracking, warping, or other signs of material deterioration.

Exterior wall surfaces are exposed to constant environmental stress and should be routinely maintained to preserve their protective function and appearance. Monitoring these areas over time and addressing issues promptly can help prevent further deterioration and potential water intrusion.

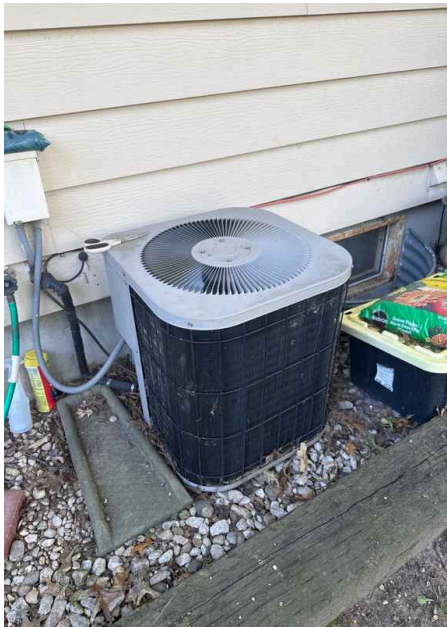
Exterior Systems: Manufactured Date

1998

According to InterNACHI, the typical service life of a central air-conditioning unit is approximately 7 to 15 years. Systems beyond this age may experience reduced efficiency, increased repair needs, and higher risk of failure. Regular maintenance and servicing are recommended to help extend service life. For more information, see: [InterNACHI's Standard Estimated Life Expectancy Chart for Homes](#)

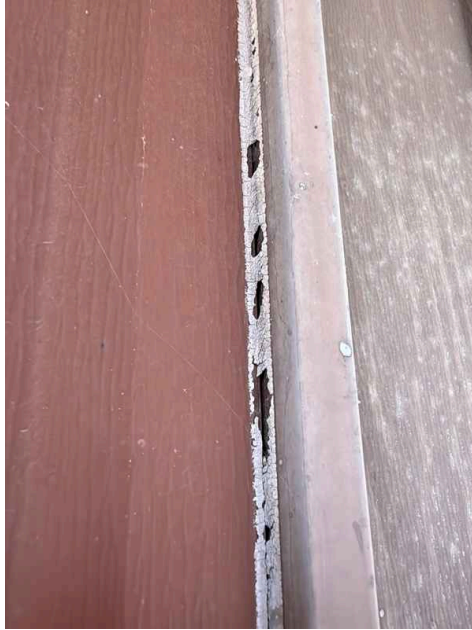
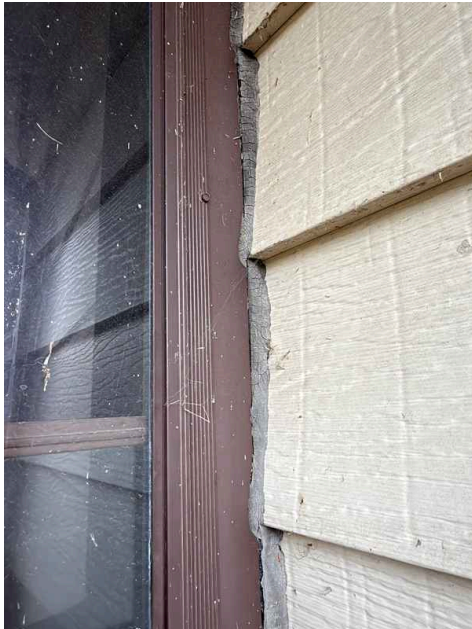
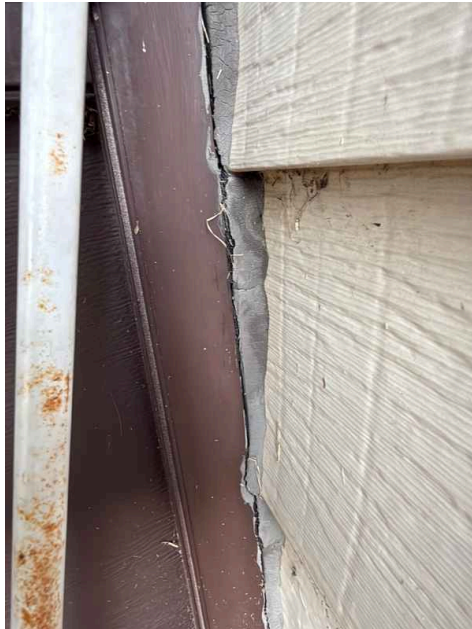
DETERIORATED CAULKING NOTED

Deteriorated caulking was observed during the exterior inspection, which can allow water penetration into wall cavities and structural components. Caulking is a critical exterior sealant that prevents moisture intrusion and maintains building envelope integrity. This creates potential risks of water damage, wood rot, and potential mold growth. Recommend having a professional inspect and replace all deteriorated caulking to prevent further moisture-related damage.

Contact a qualified professional.

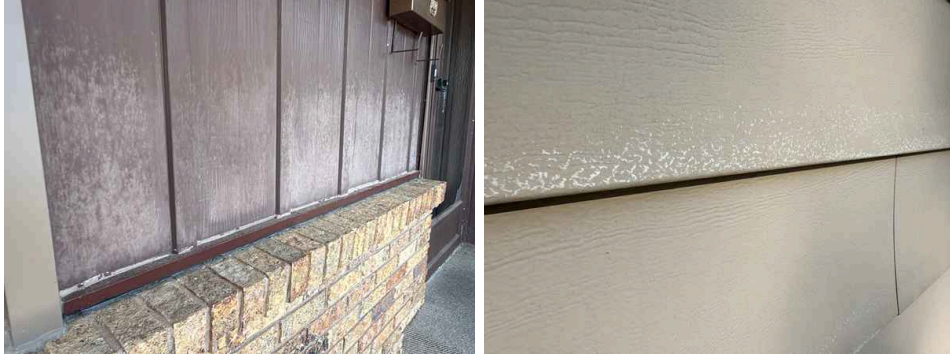
2.1.2 Wall Covering / Structure

**PAINT SURFACE IN POOR CONDITION**

Observed indications of deteriorated paint or stain surfaces, including flaking, cracking, or worn areas. This condition can expose underlying materials to weathering and decay. Correction and further evaluation by a qualified contractor is recommended.

Contact a qualified painting contractor.

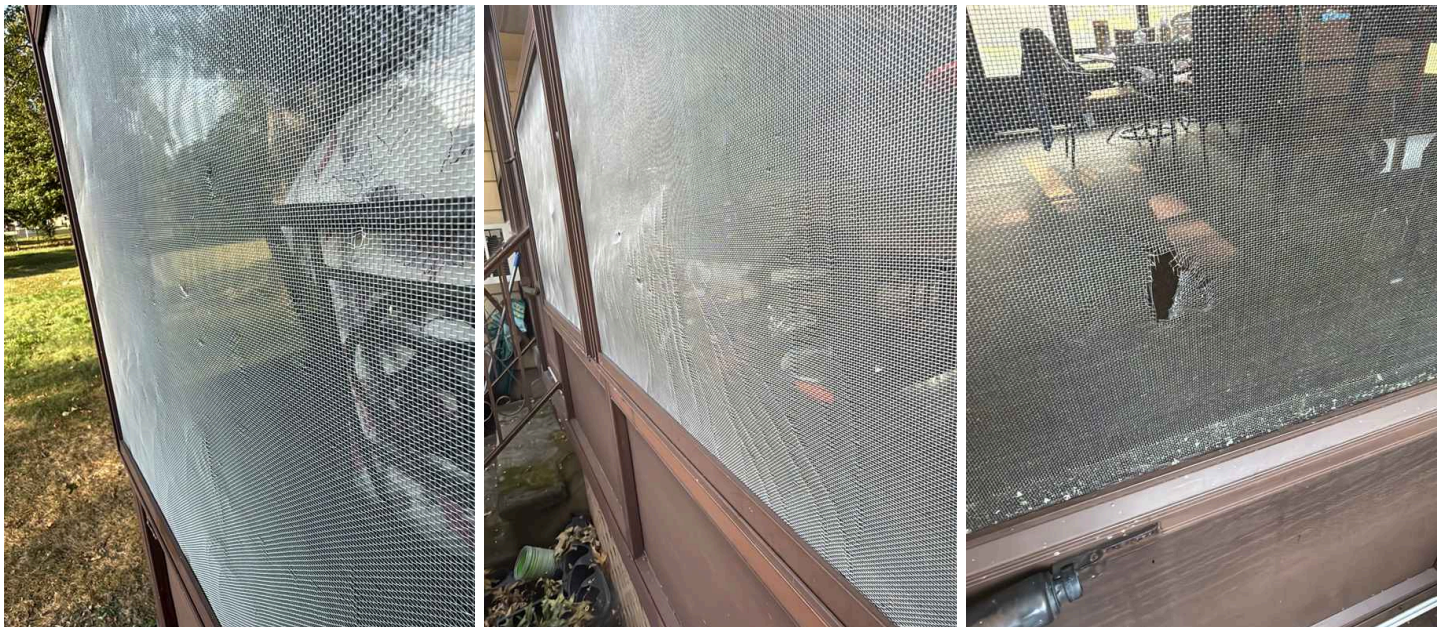
2.2.1 Openings (Windows & Doors)

**DAMAGED WINDOW SCREEN**

A damaged window screen was observed. This condition may reduce functionality, limit ventilation, and allow insect intrusion. Correction and further evaluation by a qualified contractor is recommended.

Contact a qualified handyman.

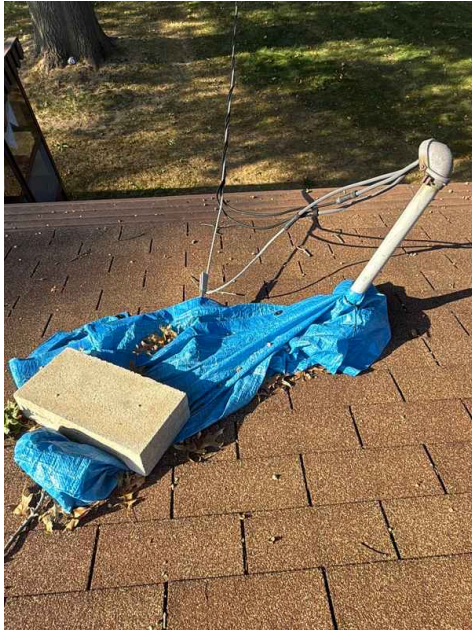
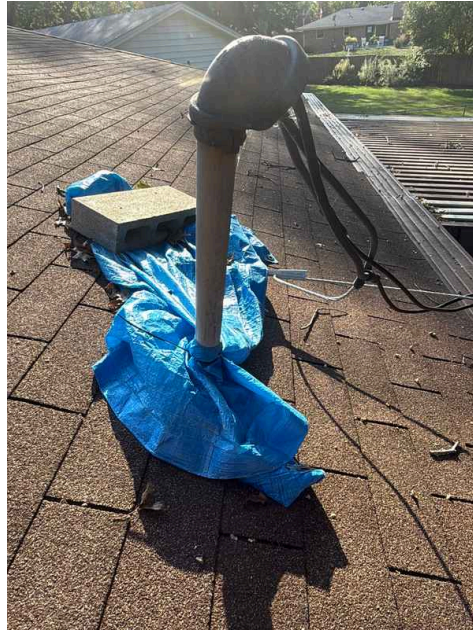
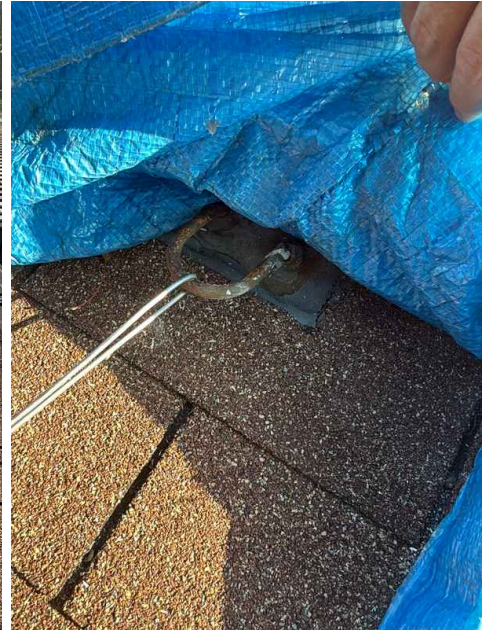
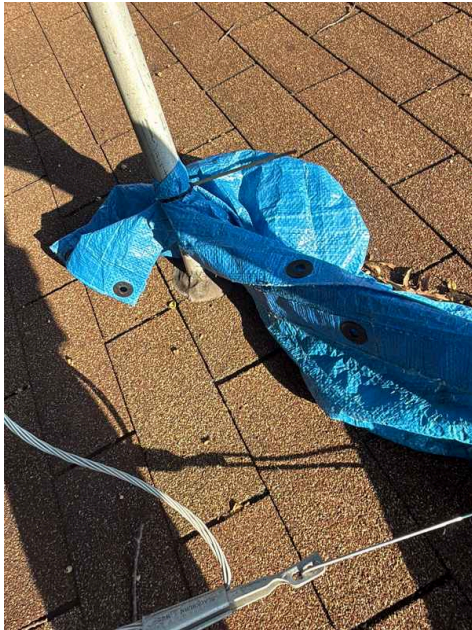
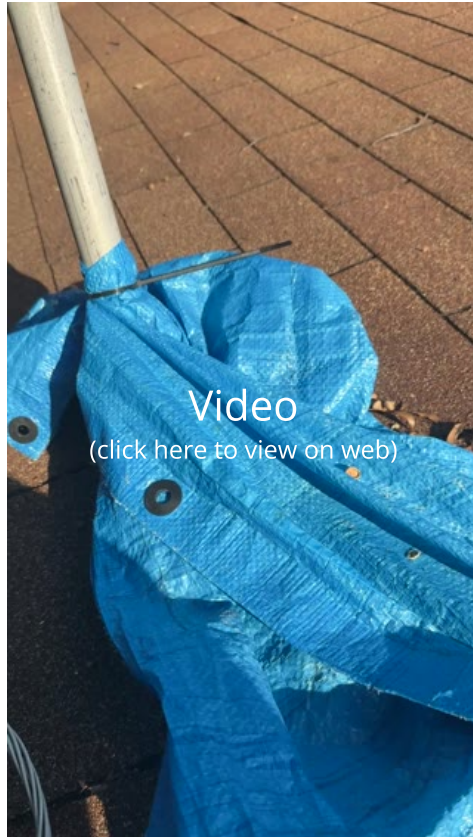
2.3.1 Exterior Systems

Material Defect

DAMAGE AT MAST

Damage was observed at the electrical service mast. A damaged mast can compromise the safe support and protection of service conductors, creating fire and shock hazards. **Immediate evaluation and repair by the electrical utility provider or a licensed electrician are recommended.**

Contact a qualified electrical contractor.

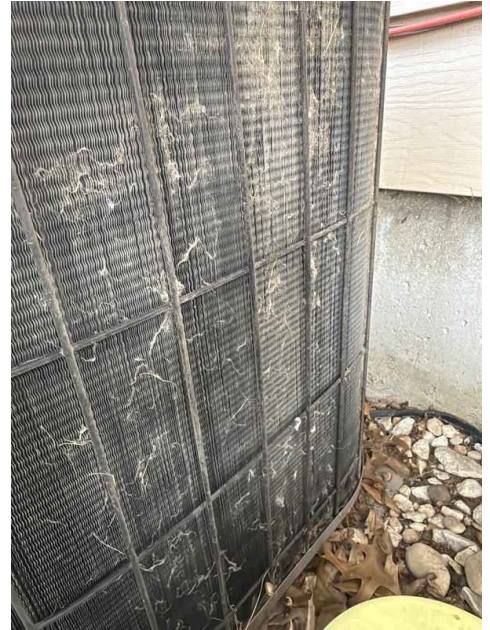
Dirt and debris were observed restricting airflow to the air-conditioning unit. Restricted airflow can reduce efficiency, increase wear on components, and shorten system lifespan. Cleaning and maintenance by a qualified HVAC contractor are recommended.

Contact a qualified HVAC professional.

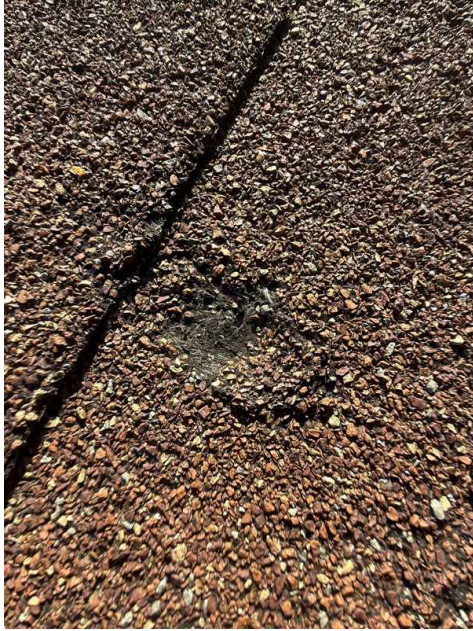
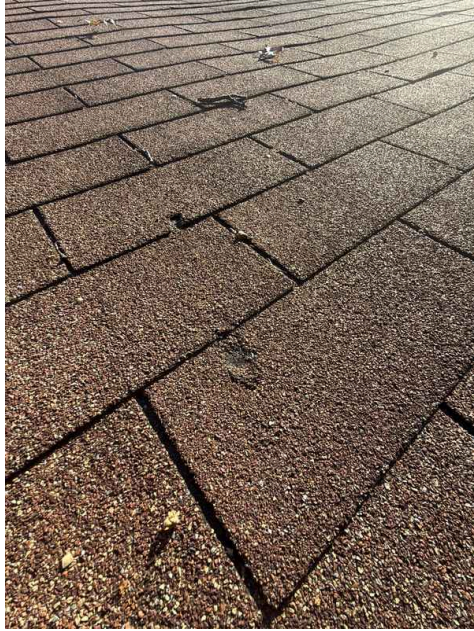
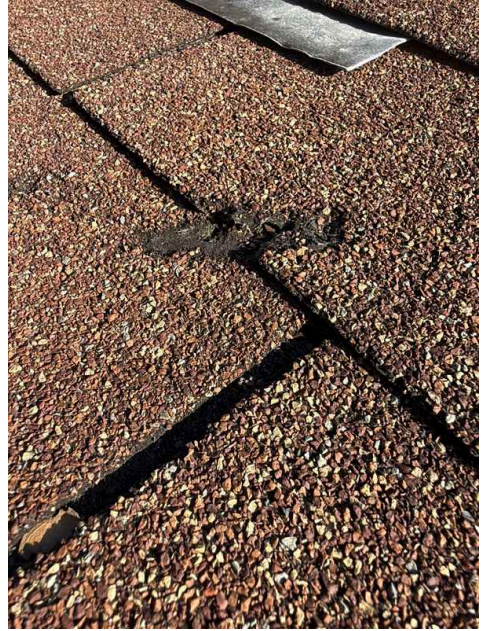
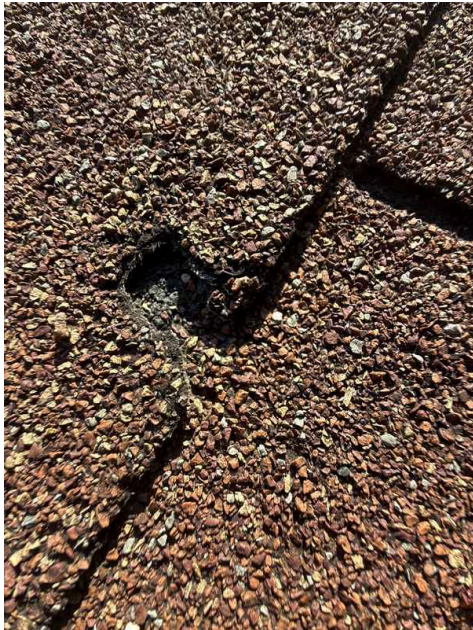
3.1.4 Roof Covering Materials

SUSPECTED HAIL DAMAGE TO ROOF COVERING

Areas of the roof covering exhibited marks consistent with possible hail damage. This condition may affect the service life of the roofing materials. Evaluation by a qualified roofing contractor is recommended.

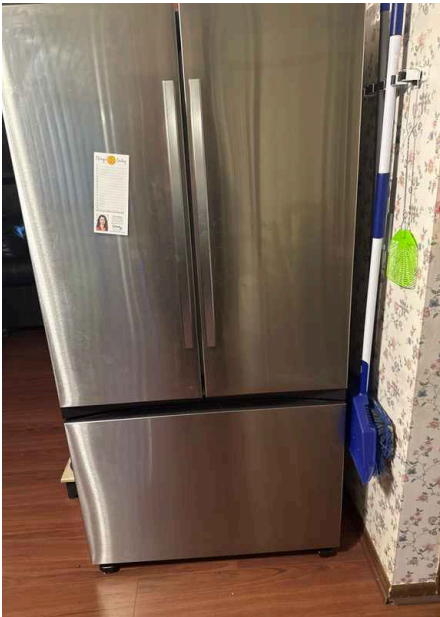
Refrigerator: Refrigerator Operation Check

The refrigerator was observed to be on at the time of inspection. No further inspection or testing was performed, as refrigerators are beyond the scope of a home inspection.

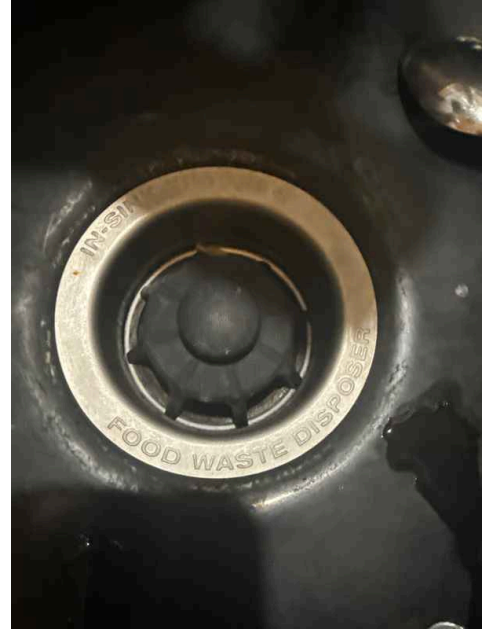
GARBAGE DISPOSAL NOT OPERATED

The garbage disposal was not operated during the inspection because the unit was either not powered, unplugged, or contained items left by the occupant. As a result, the condition and performance of the disposal could not be evaluated.

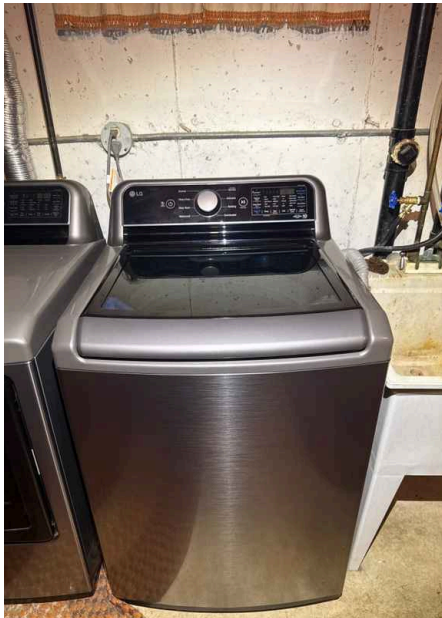
Clothes Washer: Manufacturer

LG

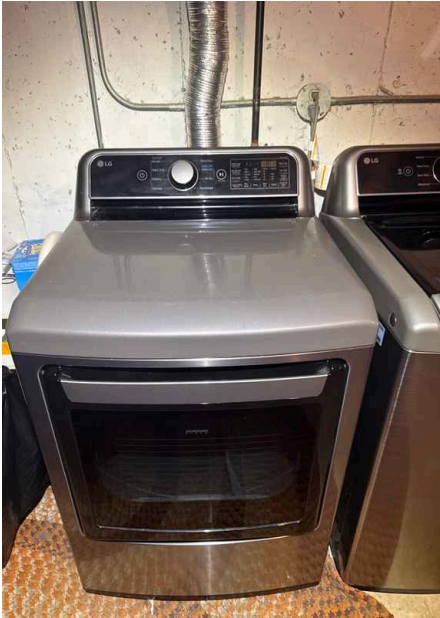
Clothes Dryer: Manufacturer

LG

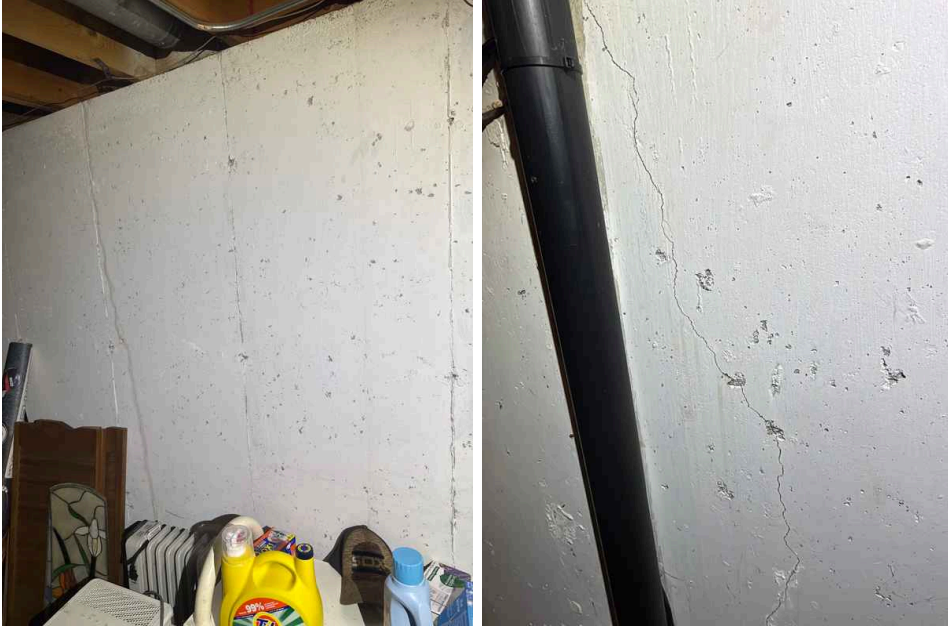
**FOUNDATION CRACK - MINOR**

A hairline crack was observed at the foundation. No major displacement or signs of significant movement were noted at the time of inspection. Monitoring is recommended to identify any changes over time.

Recommend monitoring.

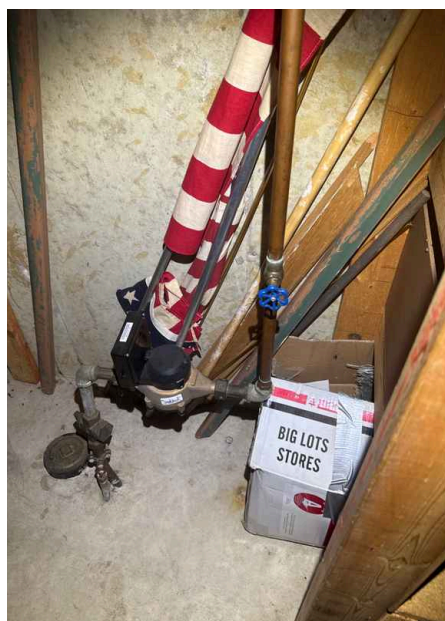
Location of Main Water Shut-Off Valve

Basement

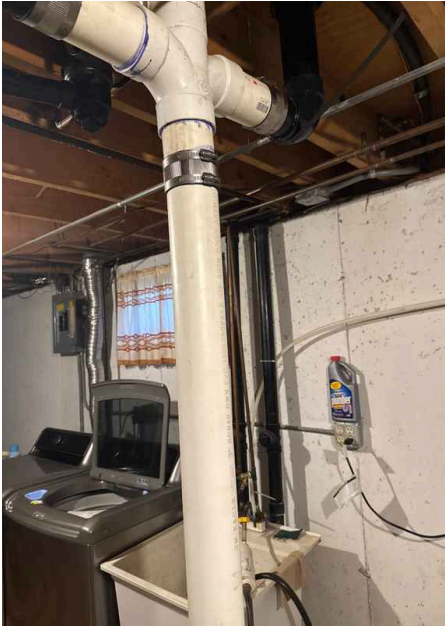
Drain, Waste, & Vent Systems: Drain, Waste, Vent Pipes Inspected

The drain, waste, and vent (DWV) piping was inspected where accessible. Portions of the system were not visible due to finished surfaces or other obstructions, which limited the inspection. Confirmation of past performance, including any history of leaks or blockages, should be obtained from the homeowner.

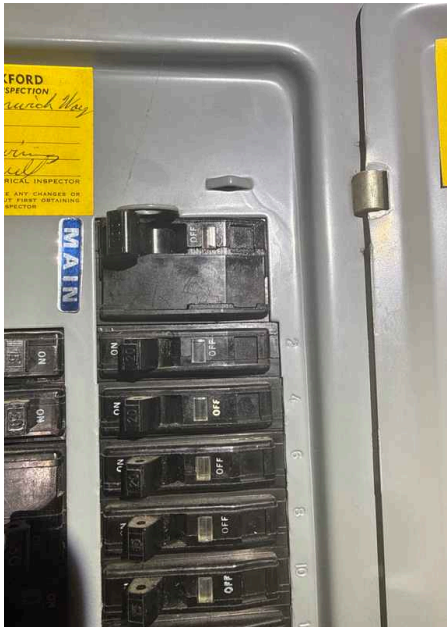
Main Service Disconnect: Main Service Disconnect Inspected

The electrical main service disconnect was inspected where visible and accessible. The inspection was limited to observable conditions at the time of inspection.

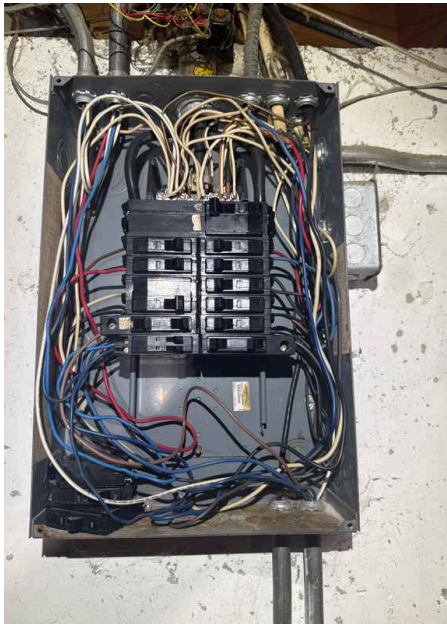
Panelboards and Breakers: Main Panelboard and Breakers Inspected

The electrical panelboards and breakers were inspected where accessible. Inspection included visible components, overcurrent protection devices, and evaluation of AFCI and GFCI protection where present.

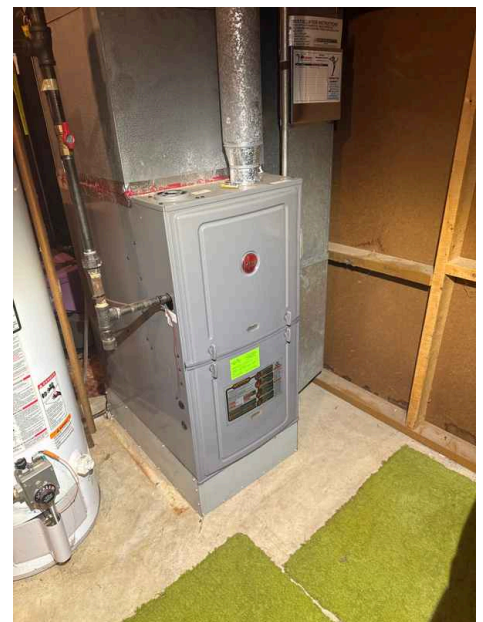
Manufacturer

Rheem

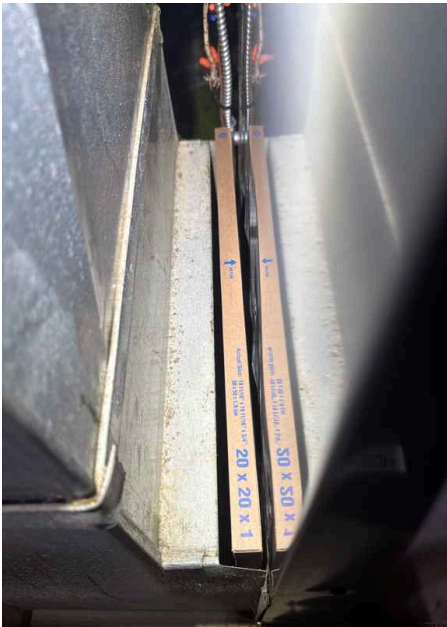
20x20x1

Air filters should generally be checked every 1–3 months and replaced as needed. Regular replacement helps maintain system efficiency, indoor air quality, and prolongs the life of the heating system.

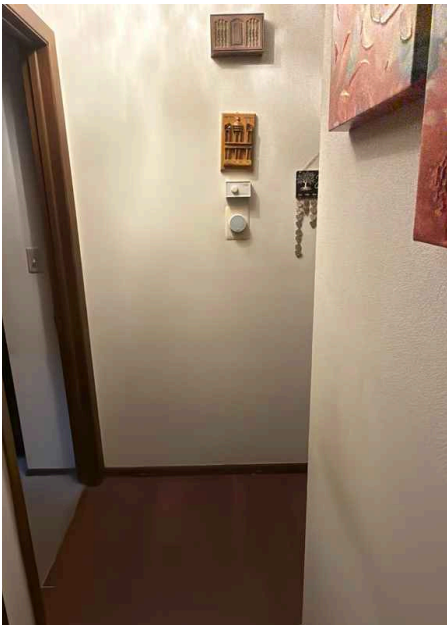
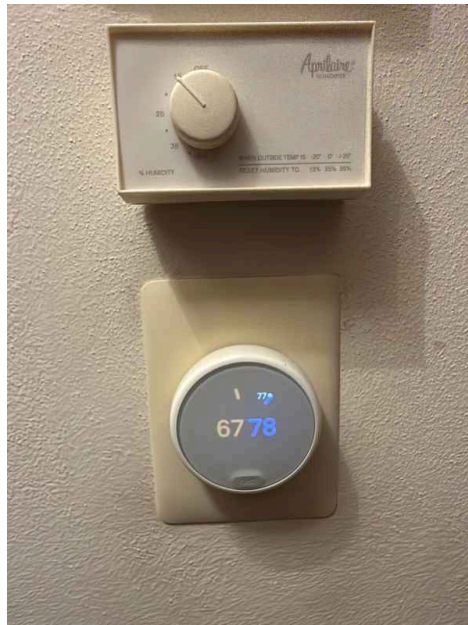
Thermostat: Thermostat Location

First floor

The thermostat was inspected and operated using normal controls where accessible. The thermostat location and general response to operation were observed.

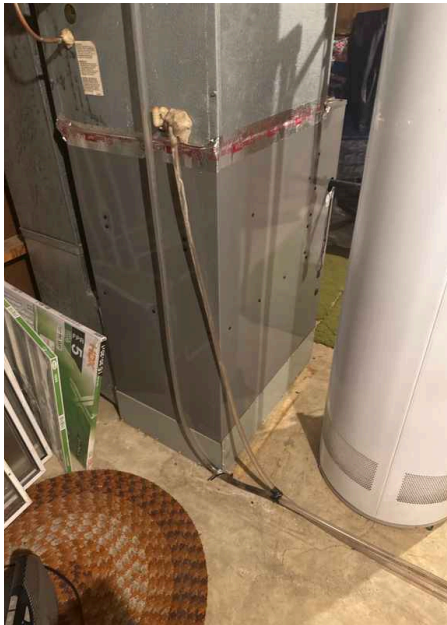
Condensate Drainage: Condensate Drainage Inspected

Visible cooling system condensate drainage components were inspected where accessible.

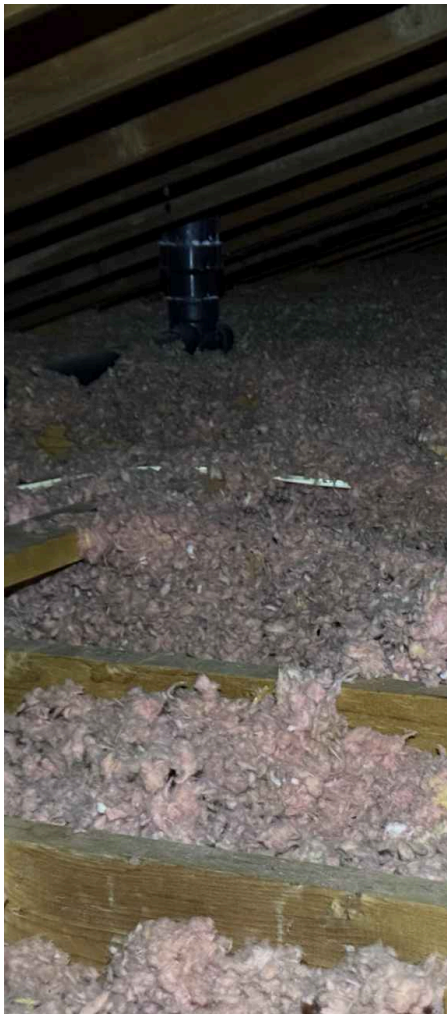
Attic Structure: Structural Components Inspected from Attic

The structural components visible in the attic were inspected in accordance with the [Home Inspection Standards of Practice](#). Attic inspections can provide valuable information about the condition of roof framing, ventilation, insulation, and potential moisture intrusion. However, many areas are concealed by insulation or finishes and cannot be fully evaluated during a visual inspection. Regular monitoring of the attic is recommended to help identify leaks, structural concerns, or insulation deficiencies early.

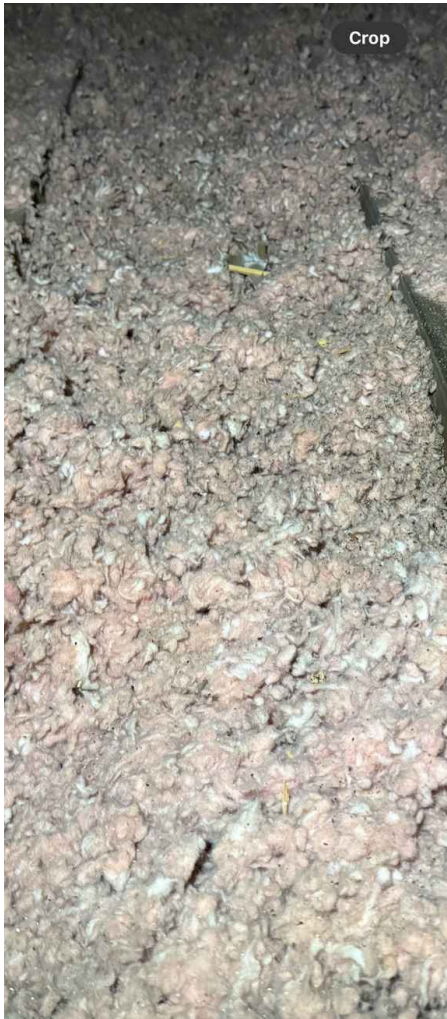
Attic Insulation: Insulation in Attic Inspected

The insulation in the attic was inspected, along with unfinished areas such as crawlspaces and foundation spaces. Ventilation of unfinished spaces and the operation of mechanical exhaust systems in the kitchen, bathrooms, and laundry areas were also inspected. Where visible, the type of insulation and the approximate average depth at the attic floor or roof structure were noted. The general absence of insulation or inadequate ventilation in unfinished areas is reported as a condition in need of correction. Proper insulation and ventilation are important for energy efficiency, comfort, and reducing the risk of moisture-related problems.
